Wyoming Historic Site Inventory Form

Teton County Historic Site Survey

1. **Site Name:** Byron Jenkins Ranch

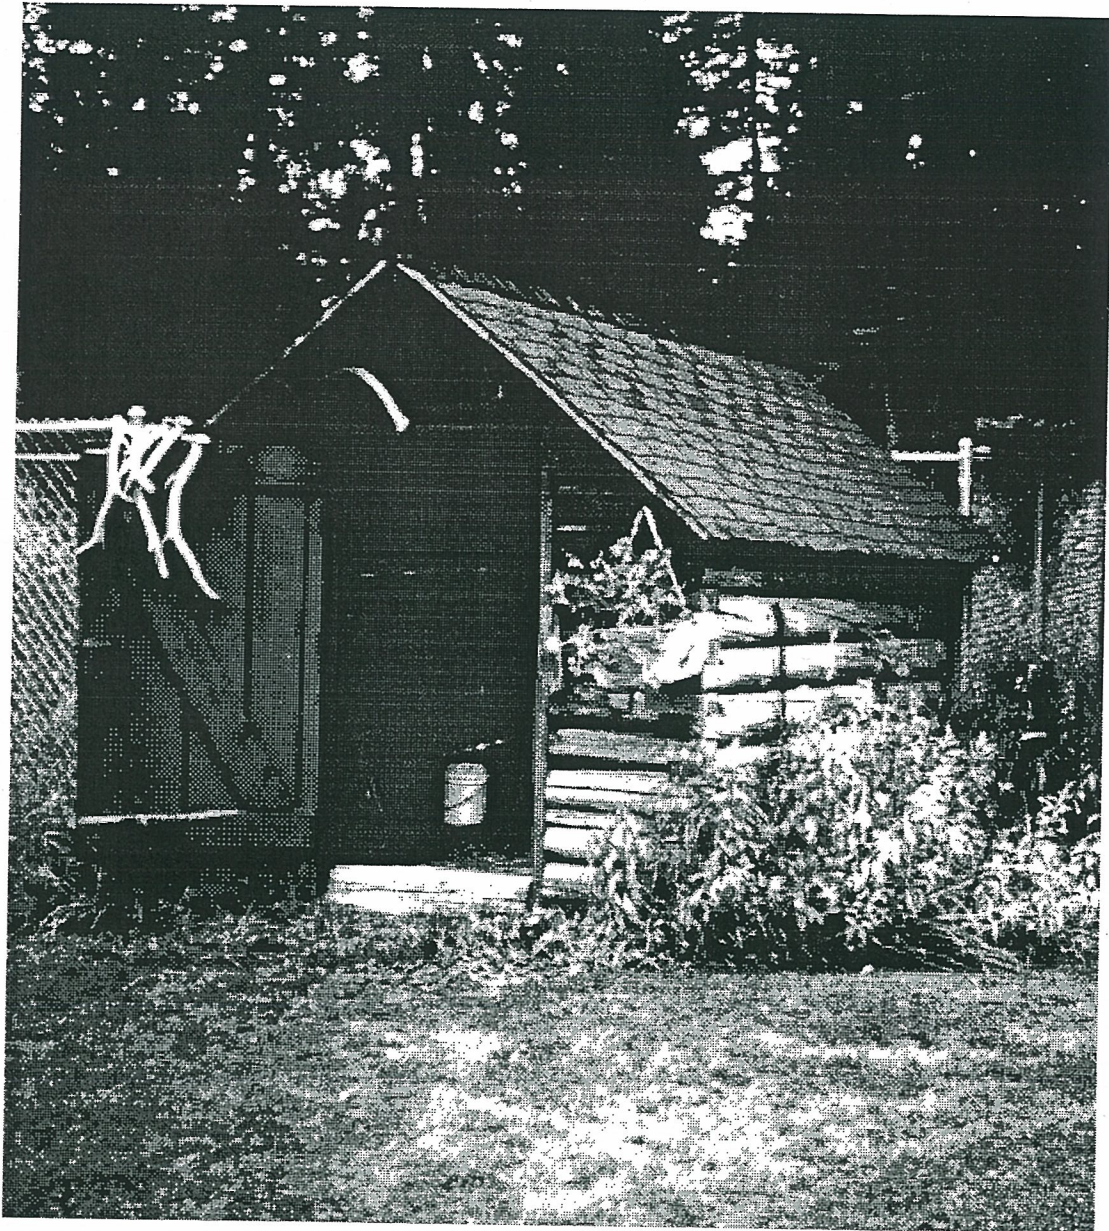
Feature 1. Storage shed.

Feature 1: Storage shed. This one-story log rectangular structure, 6' x 10', is located beside the main house to the east. Resting on a fieldstone foundation, windowless, a single entrance under the gable on the west, the round logs are joined at the building corners in a square notch pattern locally known as "tenant" and based on the mortise and tenon pattern. Five purlin tips extend slightly beyond the east and west elevations. Chinking is variously mortar, quarter pole, and no longer extant. The doorsill, a hewn log, extends well above the bottom of a centered, simple rough sown vertical board door that opens out in the west elevation. The shed retains significant integrity despite continued use since its original construction in the middle 1930s. The structure is reflective and representative of building practices and materials employed in the early and middle stages of settlement of Jackson Hole, a simple and modest and practical pattern that met needs well at the time and that has continued to do so. The medium pitched gable roof is now rolled asphalt, although it is unclear if that was the original covering.

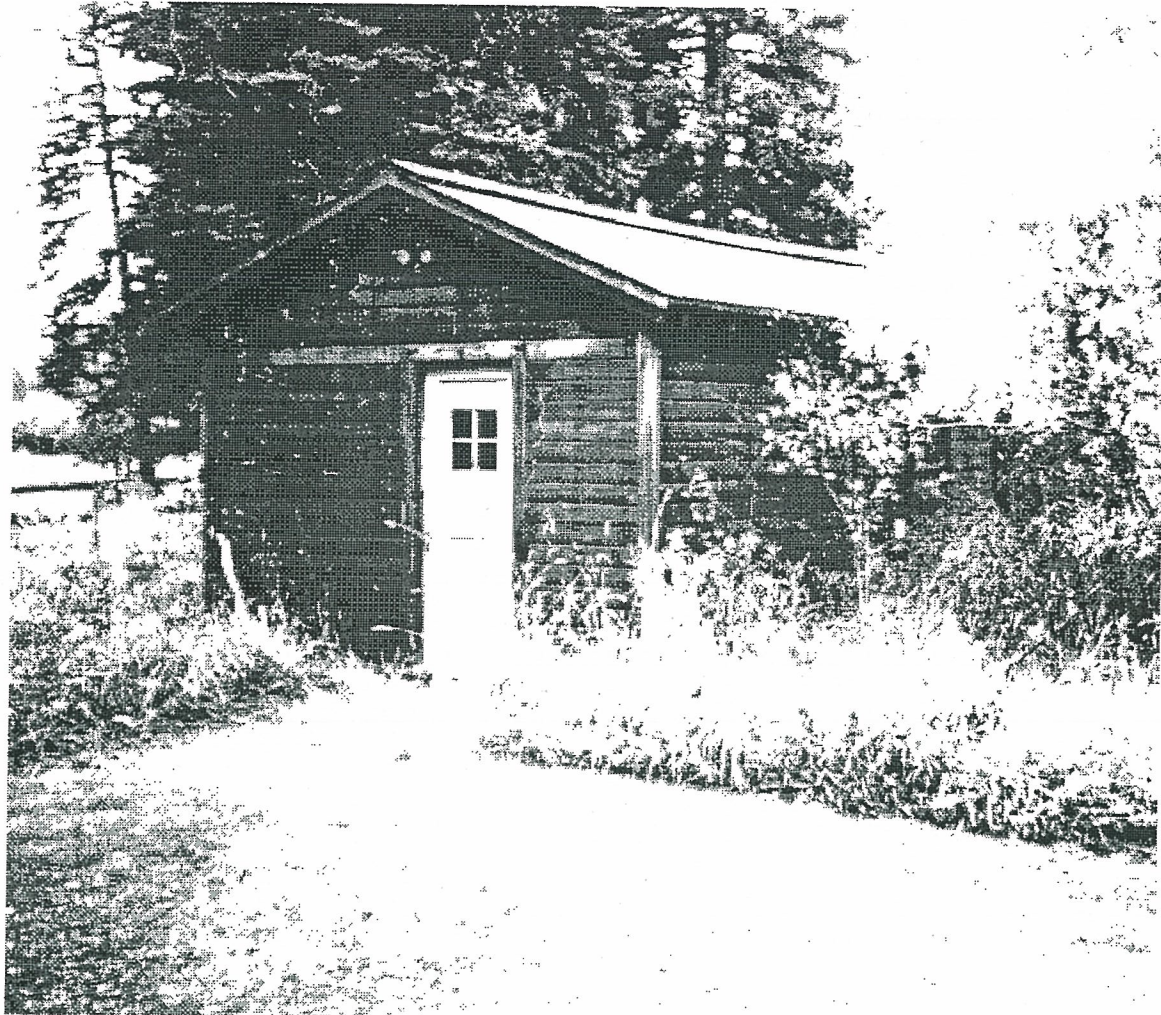
Feature 2. Well house / Pump house.

Feature 2: Pump house / Well house. This building is situated behind the main ranch house (i.e., to the south) and adjacent to (and east of) the creek which runs generally north-south through the property. Constructed in the spring of 1938 by eminent Jackson Hole carpenter Joseph Nethercott, the building style and materials demonstrate a change to patterns associated with more modern construction in the valley. A temple-form frame building with horizontal planks stained a dark brown to resemble weathered logs, each carefully finished with a beveled upper edge, the mark of a master carpenter remains clear. Exterior corners are boxed with vertical planks covering the butted horizontal planks. Neither ornate nor primitive, the building has a low-pitched east-west roof and a single entrance immediately to the north of the centerline in the east elevation. The door in that entrance contains two panels, with four lites in the upper section and the familiar x of braces in the lower panel. Asphalt shingles cover the gable roof, the ridge of which is reinforced externally with ridge boards. Cross gables on the west elevation of the building extend slightly beyond the main north-south elevations to provide a slight T-shape. The structure remains in excellent condition, a testimony to the workmanship evident in its original construction.

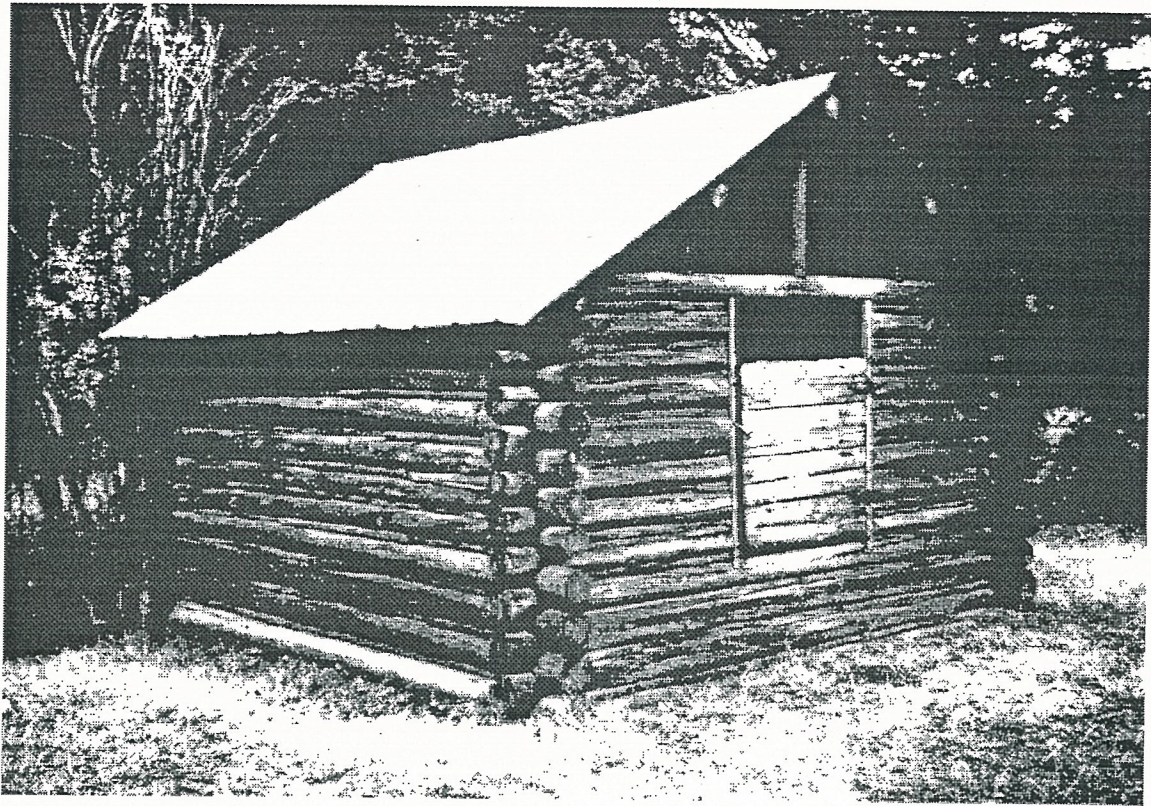
Feature 4. Ice house.

Feature 4: Ice house. Constructed in spring and summer, 1938. Carpenter Ed Hageman constructed this practical building in a rectangular twelve by fifteen foot configuration adjacent to and west of the creek (a channel of Crane Creek). No longer used for its original purpose, it accomplished its original intentions well with solid ten to twelve inch round logs chinked with quarter poles to retain cool temperatures for the preservation of ice removed from the creek in the winter. Corner joints are saddle notched, with the notches in the lower sides of the logs and the sawed crowns project beyond the elevations in each direction. Erected next to the stream and shaded on the south and east, the design of the structure reflected not only careful workmanship but also genius of location. A metal gabled roof reflected the heat of the sun and an open gable—the entire triangular section bounded by the two roof slopes—on the west elevation provided ventilation so that heat

would not build in the structure. What might appear to be an oversized window with a hinged batten door about two feet from the ground provided access to the ice house while preventing the cold at the floor level from escaping when open.

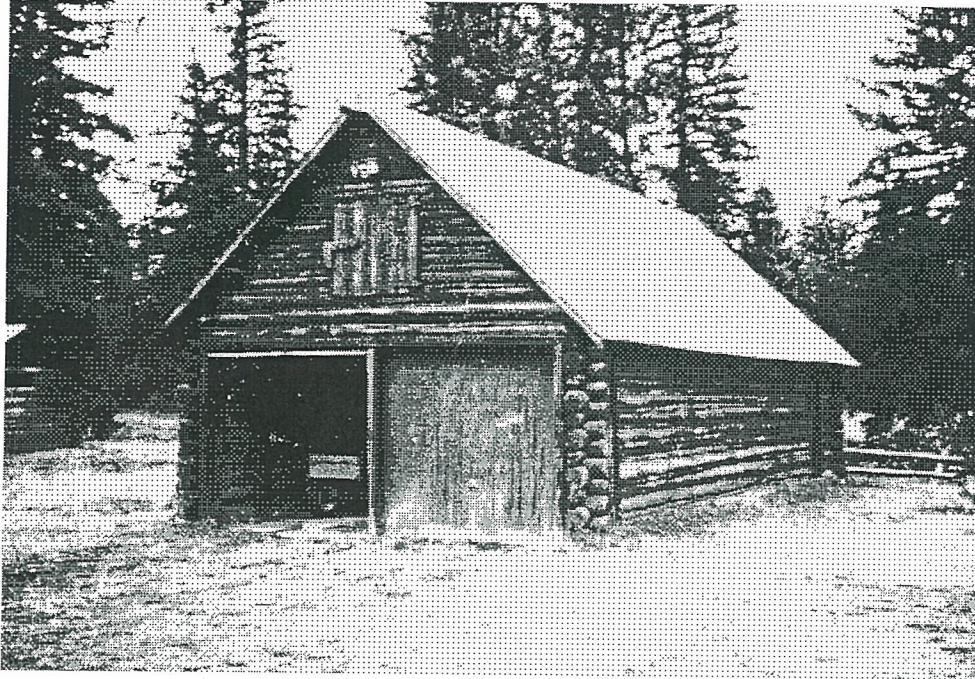
Feature 5. Barn / Stable.

Feature 5: Barn / Stable. Constructed in 1940 by Byron Jenkins and Lou Blair, this log structure again reflects the combination of workmanship, design, and placement to achieve its original purposes and its current integrity reflects both successful construction and continued maintenance. A one and one-half story rectangular building with a hay loft, two entrances with solid paneled doors that open vertically, sliding back overhead, and an opening to the hay loft above the entrances enclosed with a single board and batten door, the log construction was both methodical and deliberate. The building measures thirty-five feet long and thus required carefully selected timbers to achieve that length without joints. Saddle corner joints, again with the upper log notched on its lower side, and with sawed crowns projecting beyond the elevations, provide consistency with other buildings on the property built around the same time. Quarter pole chinking remains in excellent condition. The gable roof once was covered with wooden slabs but is now covered with corrugated metal roofing; a hay hoist projects above and beyond the hay loft entrance directly under the ridge. The fieldstone foundation has been replaced with concrete. A generally open interior, the south end of the barn at one time contained stalls and stanchions for four milk cows. A single batten-board door opens into that portion of the barn on the south end of the west elevation. The building is now used as a garage.

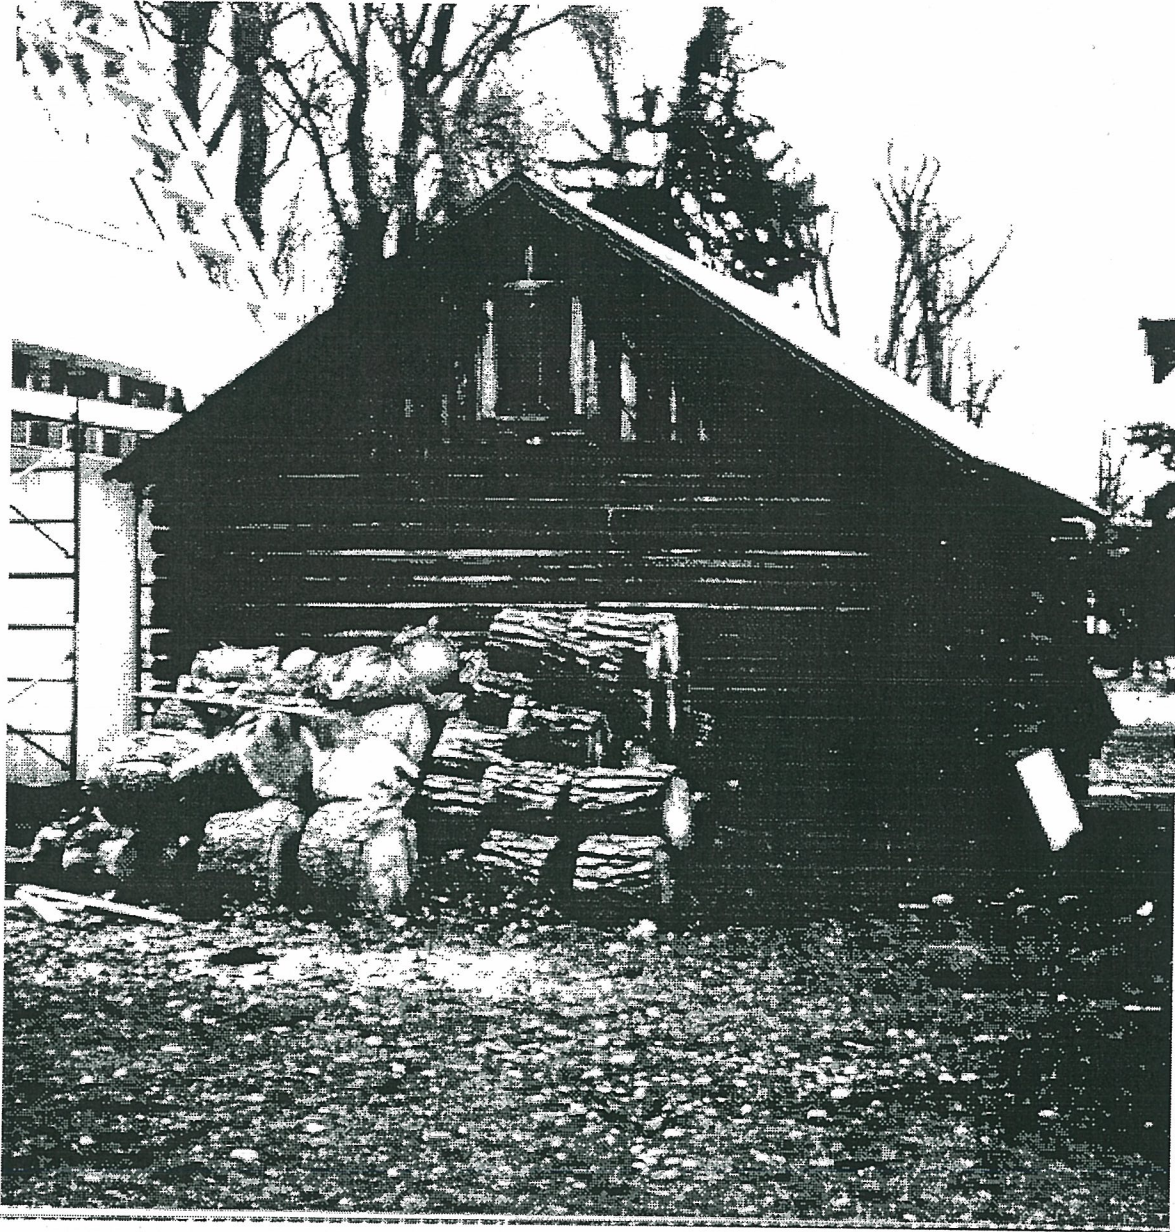
Feature 6. Granary

Feature 6: Granary. Constructed in the spring of 1938 by a carpenter named Henrie, the granary faces north toward the meadow and parking area of the ranch. Now on a concrete foundation, the building's front elevation measures approximately twenty-four feet and the building's east and west elevations are constructed of logs twenty feet long. Saddle notches with sawed crowns once again conform to that of contemporary buildings on the ranch, but chinking is with mortar instead of quarter-poles. As with the other buildings, all logs are peeled and have weathered or been stained to a dark finish. Vertical planks completely enclose the gable end above the logs in the north elevation, but a two-lite window is centered beneath the ridge and above the logs in the south elevation. Corrugated metal roofing now covers the gabled roof. A modern garage immediately east of the granary and a new barn under construction in autumn, 1997, immediately to the west, are both non-contributing buildings.

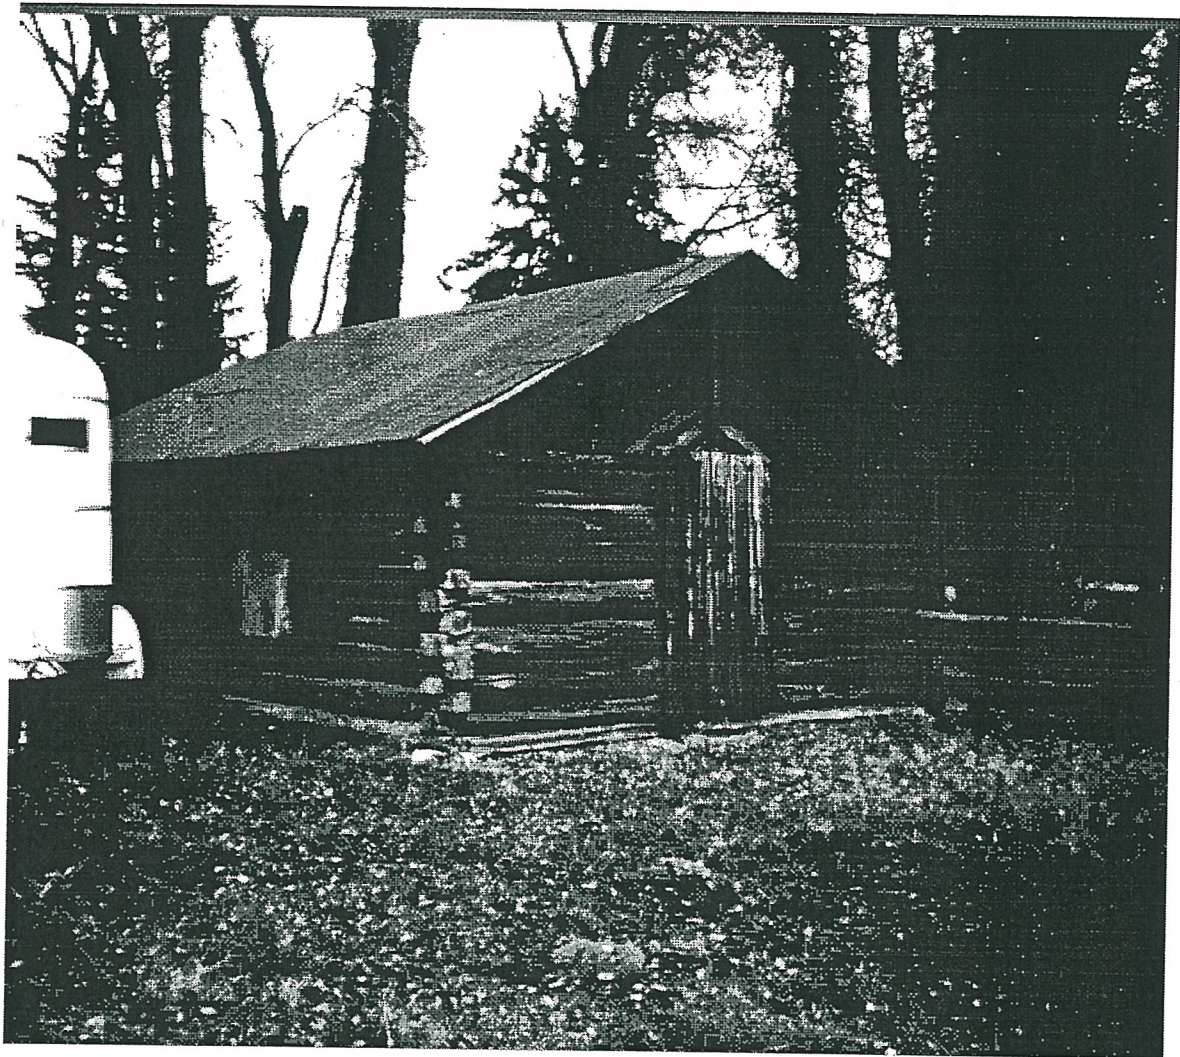
Feature 7. Blacksmith shop

Feature 7: Blacksmith shop. Characteristic of many historic structures in Teton County, this building was moved from its original location to a new location. This structure came from the Sewell/Meyer (?) Ranch directly north of the Jenkins Ranch and was used on the Jenkins Ranch as a blacksmith shop. Both by local understanding and structural analysis, this shop dates to the beginnings of the twentieth century, or earlier, although precise dating is not possible. A general clue in its construction, though, confirms its origins as prior to that of the other buildings on the Jenkins Ranch and most buildings in the county. Approximately fifteen feet square, the logs are clearly older and more stressed and they are

joined in a square notch ("tenant") pattern; the crowns project slightly, although at first glance they would appear to be flush with the elevations. In that sense the construction was neither as sophisticated or meticulous as evident in other Jenkins buildings and the tools used appear to have been fewer with the result that the logs are not so carefully fitted. Chinking is mortar. The foundation is fieldstone piers. The single entrance is in the south elevation, a board and batten door on metal hinges that opens outward. The gable roof is now covered with rolled asphalt and the gable and purlins project two feet beyond the elevation. Diagonal planks completely enclose the areas above the logs and enclosed by the gables on both north and south facades. A boarded-up window is centered on the west elevation.

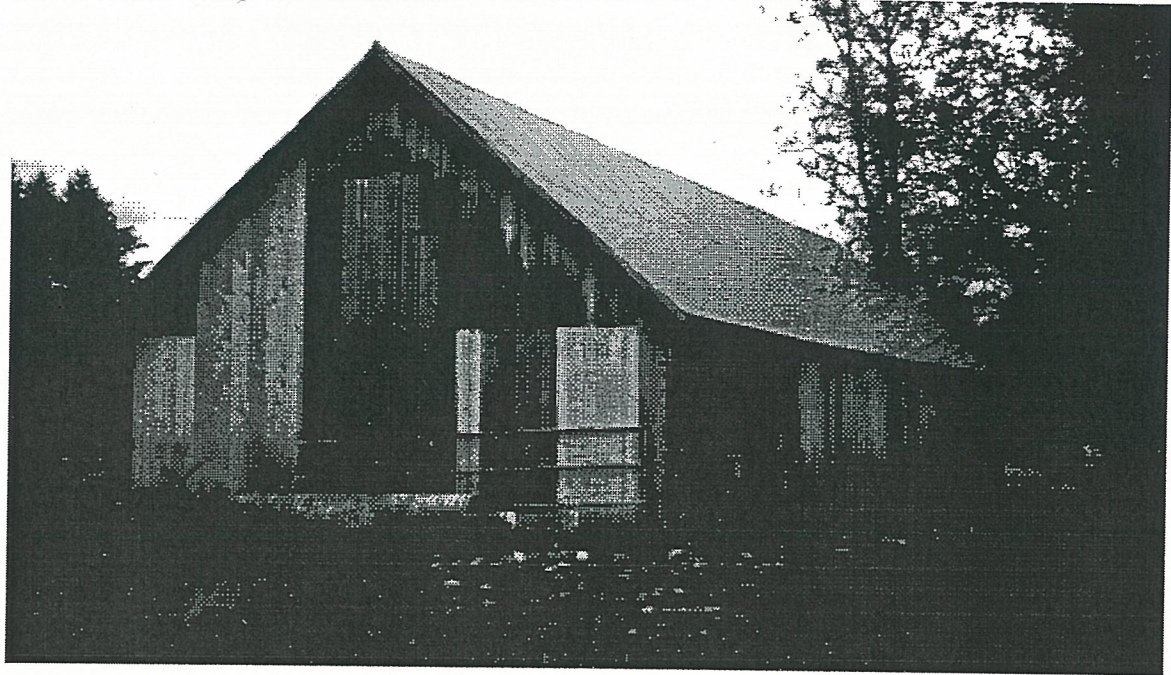
Feature 8. Machine shed.

Feature 8: Machine shed. Constructed in the summer of 1938, the machine shed is a rectangular two-story building approximately sixty feet long (east and west elevations) and twenty-five feet wide. The gable roof is covered with corrugated metal. The east elevation is completely open, four vertical logs separating the open interior into five bays. The remaining elevations, however, are constructed of vertical planks resting on a fieldstone foundation. A loft entrance in the north elevation has been enclosed by vertical planks.
