Wyoming Historic Site Inventory Form

Teton County Historic Site Survey

1. *Site Name:* Anchor Ranch

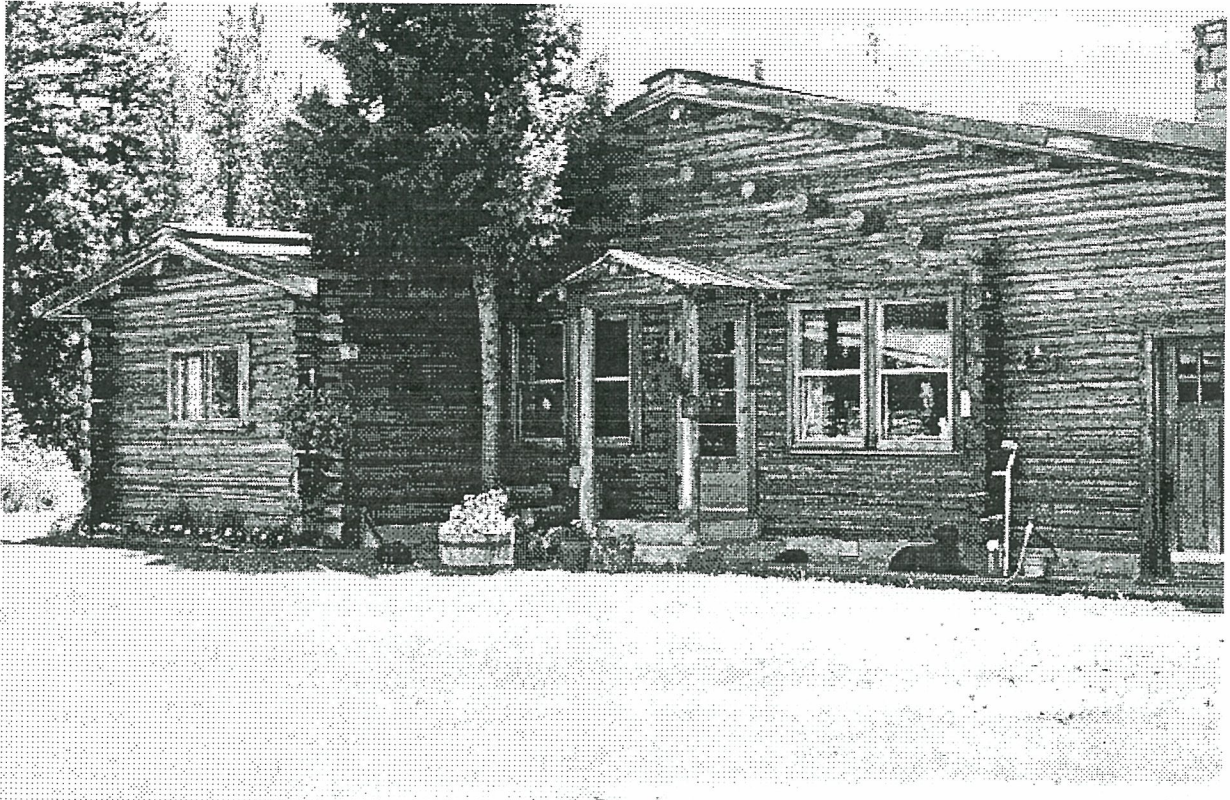
Feature 1. Main house. North elevation.

Feature 1. Main house.

The main house of the Anchor Ranch, built before or at the latest at the beginning of World War II, is a rectangular log structure with several modifications that provide it a slightly irregular configuration. Stretching wide across its northern elevation, under a gently sloping gable roof, the logs are chinked with quarter poles and the corners are saddle-notched. Nine purlins are exposed, slightly, under the eaves on the west slope of the roof and fewer are visible under the east slope of the roof because of an addition that interrupts the eave and projects northward. That addition, with a gable roof, represents an augmentation of the bedroom on the east side of the building. The most distinctive aspect, and the most noticeable feature of the north elevation is the set of purlins exposed that repeat the gable configuration of the roof about three feet beneath the roof. Investigation reveals those purlins to be the support for a second, interior (or false) roof and ceiling; that is to say that the interior ceiling is about three feet lower than the exterior roof although the two follow generally the same contour. Those purlins and then the crowns extending in a tidy column west of the windows (two double hung windows on each side of the entrance) and then the bedroom addition on the east, together neatly frame the entrance and windows on the north elevation. The entrance, directly beneath the gable ridge, is a single door with glass panel and is covered with a gable canopy supported by two vertical logs that rise from the porch stoop. Small logs fill in the northern elevation space under the miniature gable of the canopy. In this way three sets of gable lines, at approximately the same pitch, strike the viewer—first the canopy over the porch, then the purlins of the false roof, and then the roof itself. Of course, the gable over the bedroom addition to the east, continues and repeats the same lines. On the east portion of the north elevation, the bedroom extension projects approximately eight feet north of the main elevation with matching logs and chinking. A horizontal sliding window is centered in its north elevation under the gable. West of the column of crowns west of the entrance, which obviously represent an interior wall, is another entry, much more subdued than the main entrance. A two-panel (side by side) door with six lites at the top, which opens at a level slightly lower than that of the main entry (over the stoop), though originally intended to lead down to a basement, instead opens to a storage area. A woodshed of dark brown board and batten construction extends the line of the north elevation to the west approximately twenty-five feet. With a depth of about six feet, however, that wood shed obscures very little of the west elevation. Logs continue under the west eave, interrupted by a column of crowns about midpoint, again revealing the location of an interior wall, and by three non-symmetrical windows. The south elevation of the main house could well and easily be interpreted also as a front façade. Columns of log crowns divide the elevation into thirds, with the middle segment being slightly larger than the sides. Again, the unusually large number of purlins under the gable overhangs—nine on each side—suggests the gentle slope of the roof and broad width of the building. A large horizontal single-lite window opens on the west portion (originally intended as an enclosed porch), a metal door flanked by three single-lite windows dominates the middle segment, and a smaller horizontal sliding window is centered in the east segment. All in all, the general appearance of the main house is handsome and stately without being ostentatious. Its interior is equally impressive with the golden logs and wooden planks in the ceiling having become darker from the wood fire, the fire itself burning in a beautiful and distinctive fireplace crafted by an unknown artisan whose signature work remains in a

few buildings in the valley. The rock of the fireplace is not the normal round river rock so often used in this area, but is flat, having been quarried by Redtop on Fall Creek. The flat sandstone is in an array of both colors and shapes and the rocks are arranged in a perfect symmetry in the fireplace. The rockwork is also evident from outside in the chimney that extends above the roof.

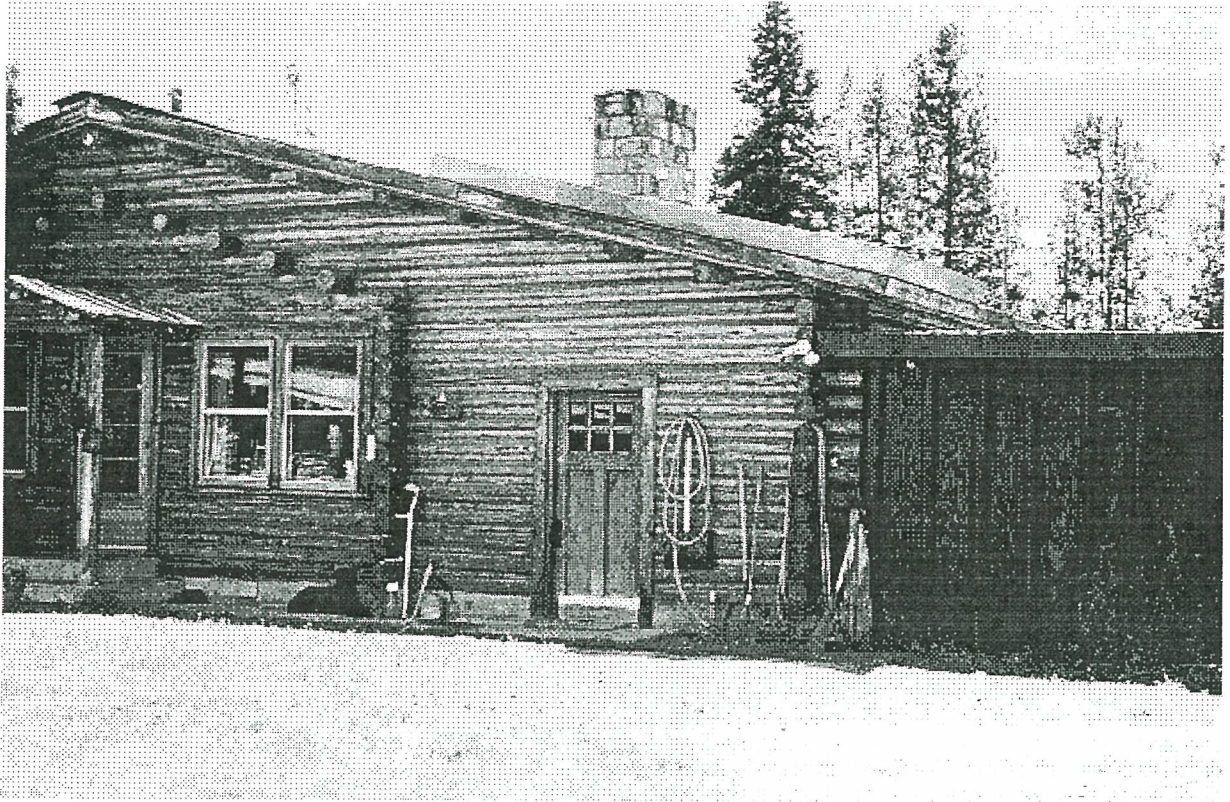
Feature 1. Main house. North elevation. Detail indicating storage entry and portion of woodshed.

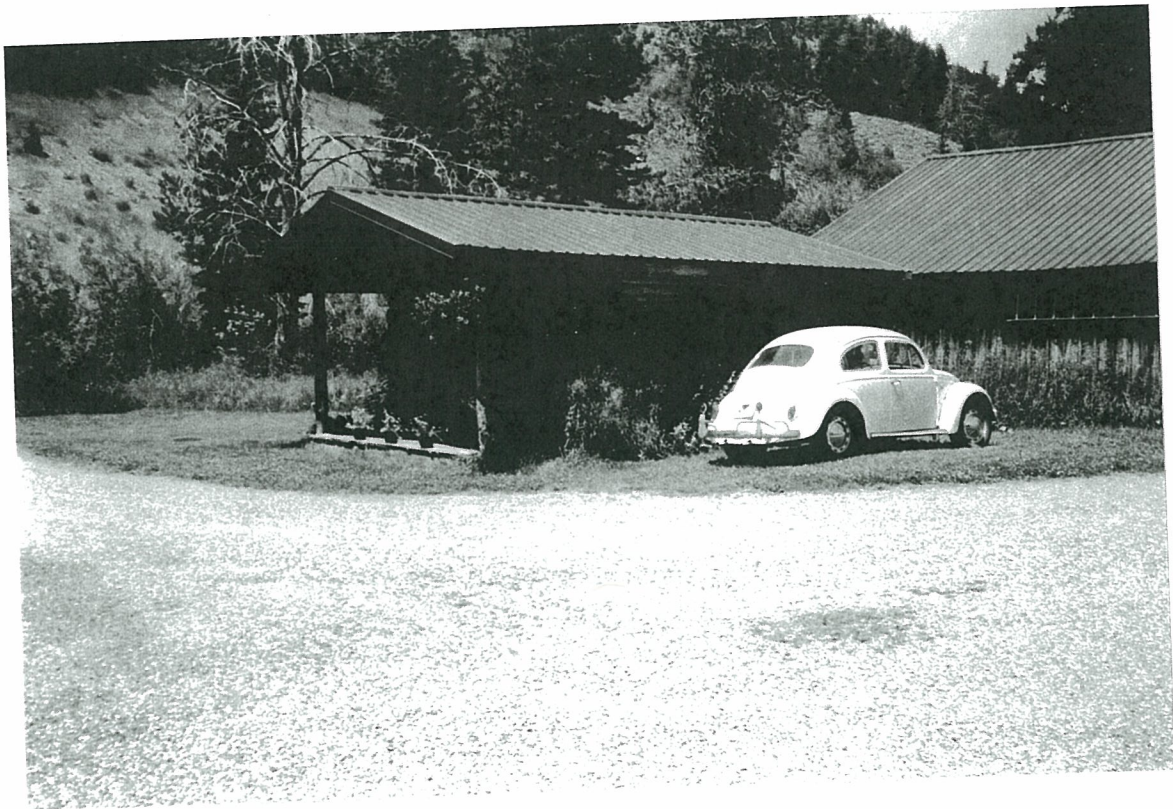
Feature 3. Guest cabin (Crystal Springs). South and east elevations.

Feature 3. Guest cabin (Crystal Springs Cabin).

A common occurrence in the valley has been, from the beginning of its settlement to modern times, the removal of buildings from one location to another for continued or different use. In an area where access has been historically difficult and where the main building resources have been those locally available, this has been a time-honored practice. The buildings of the Crystal Springs Ranch (also known as the Crystal Springs Girls' Camp) were sold and removed when Teton Village was constructed in its place. Operating especially in the post-World War II environment, the camp was popular and successful. This building, which had been one of the offices at the camp rather than a cabin for guests, was purchased and moved to its present location in 1962 or 1963. It was probably constructed around 1945. It was used on the Anchor Ranch as a guest cabin and has continued to be used as a dwelling.

The cabin is of log construction with quarter-pole chinking and saddle notched corners and sawed crowns. It bears the signature element of Crystal Springs cabins—the gable roof that projects dramatically forward over the entrance and supported by two vertical posts rising from the corners of the stoop. This is smaller than the other guest cabins at Crystal Springs—about twenty feet long and ten feet wide—because it was an office. The entry is therefore right (east) of center in the south elevation rather than centered. A pair of sliding

six-lite windows open between the door and the southwest corner and a similar set of windows is centered on the east elevation. The west and north elevations have no openings. The roof is metal.

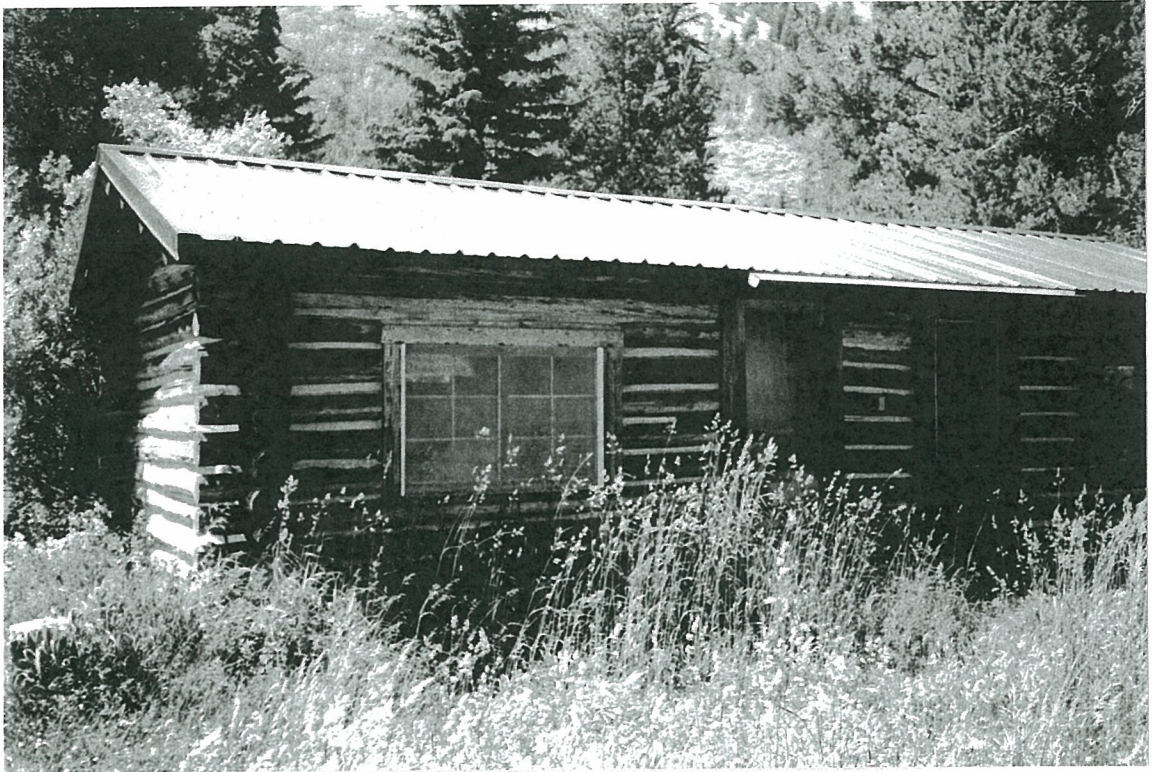
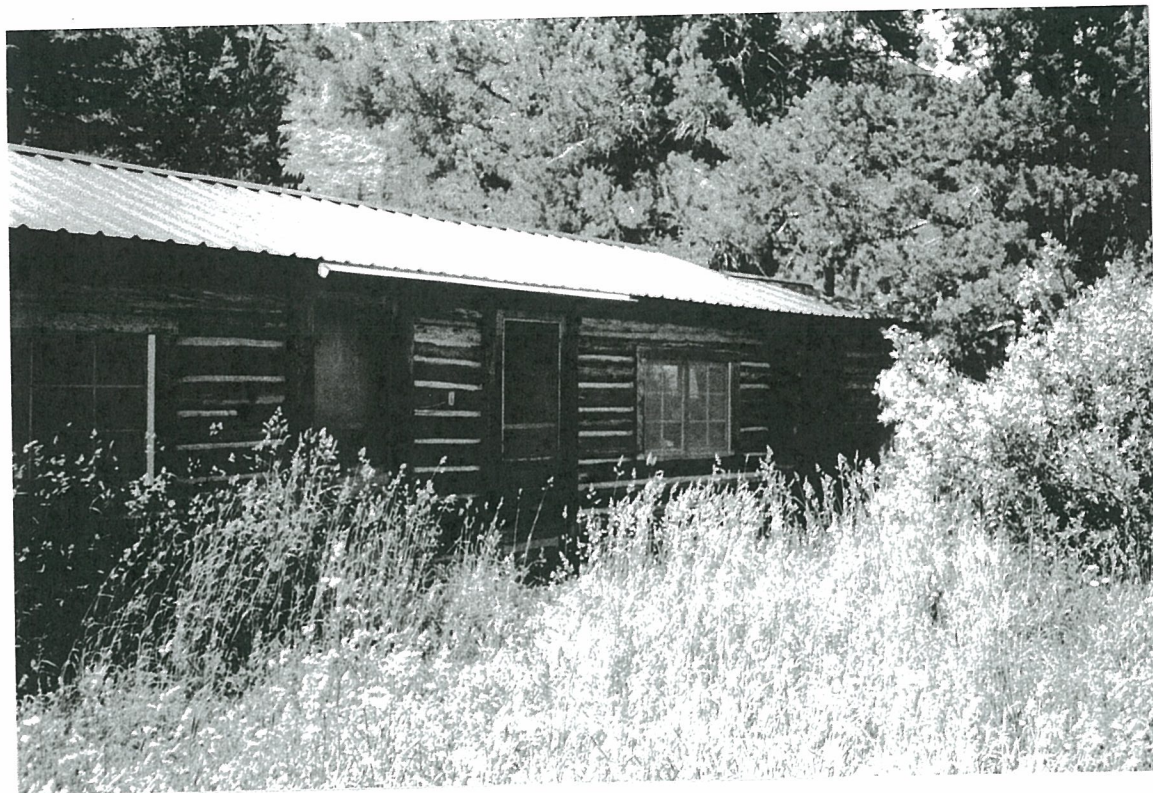
Feature 5. Guest Cabin (Baroness Elena). South and east elevations.

Feature 5. Guest Cabin (Baroness Elena). East elevation continued.

Feature 5. Guest cabin (Baroness Elena).

Again, the process of moving buildings around within the valley provides the starting point for evaluating this structure. Even though it was moved to its present location about 1950, its origins can be precisely determined. In 1929 when the Baroness Elena Gibo (Hunt) planned to develop a dude ranch south of this point at the Triangle Q Ranch, she and her partner Gib Scott built three cabins for the dudes. That planned enterprise, however, never materialized and the three cabins were used for other purposes. Two of those cabins remain on the Triangle Q. The third one is on the Anchor Ranch. All of the cabins were designed as double units (essentially duplex fashion) with a pair of doors in the center opening into the separate units. This one is exactly like the others in that respect. And they are also alike in the log construction with saddle notches at the corners and horizontal sliding windows and a metal gable roof, in this case, on the north-south axis. The entries are under the east eave. An addition to the original unit is located on its north end, with a third entry, using round log slab siding and a separate, smaller, gable roof. Chinking is mortar that appears recent. This feature is located at the far north end of the property.

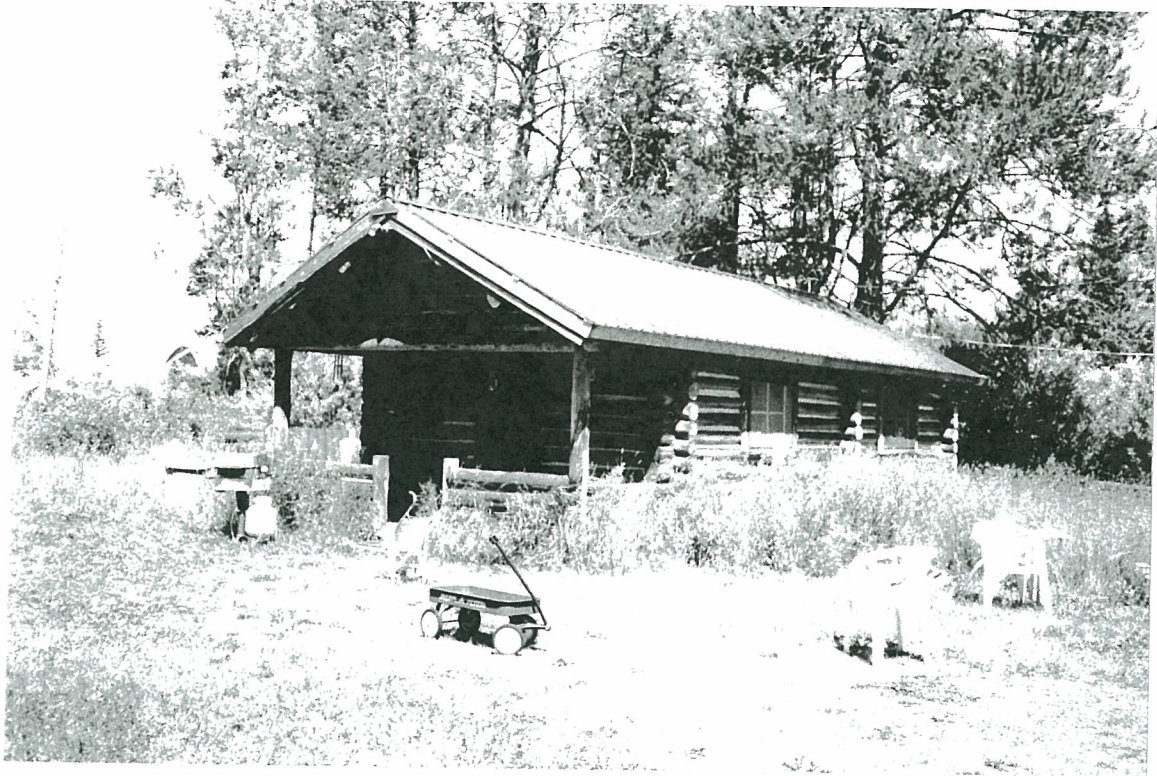
Feature 6. Budge Cabin. West and south elevations.

Feature 6. Budge Cabin.

Constructed about 1934 by James Budge when he acquired this property, this is sometimes referred to as the homestead cabin. A rectangular log structure with concrete mortar for chinking, the building is about thirty-five feet long on its north and south elevations and about eighteen feet on its east and west dimensions. A metal gable roof extends along the east – west axis and projects beyond the entry in the west elevation to form a canopy over the porch. Log posts support the overhang at the corners of the porch and unchinked logs form a partial wall of about two and a half feet around the perimeter of the porch, leaving an opening in the center of the west elevation for passage. Directly above that wall in the west elevation more logs are used to completely fill the triangular area between the gable slopes and the log that stretches across between the supporting posts. A column of crowns divides the south elevation at midpoint, where an internal wall is located. In both of the panels created horizontal four-lite windows provide openings. On the north elevation a shed addition extends slightly beyond the wall and is covered by a roof that is connected to, but slopes at a more graduate pitch than, the north eave. A separate entry to the square shed is on its west elevation. The notching on this

addition is that of a box corner, or false cornering, which uses vertical planks to form an indented V without the logs actually interlocking. A four-lite window opens on the north elevation under the eave.

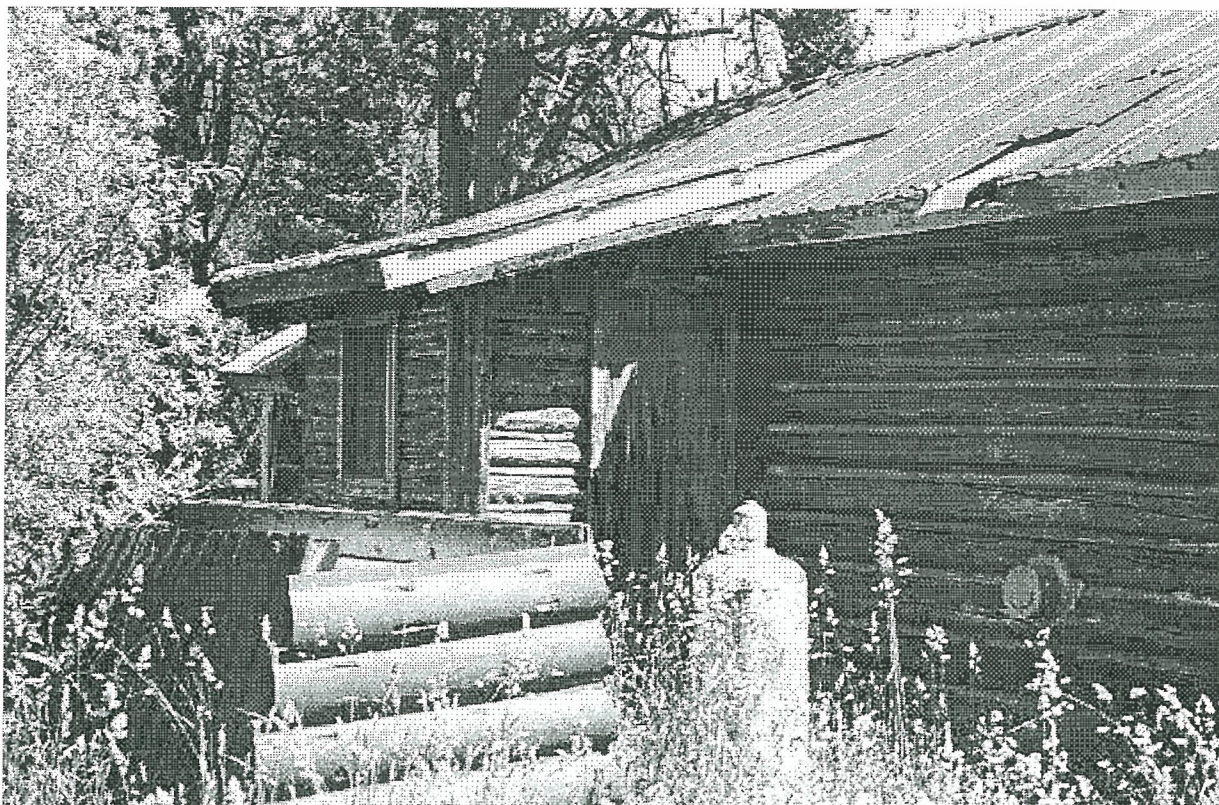
Feature 6. Budge Cabin. North elevation. Detail.

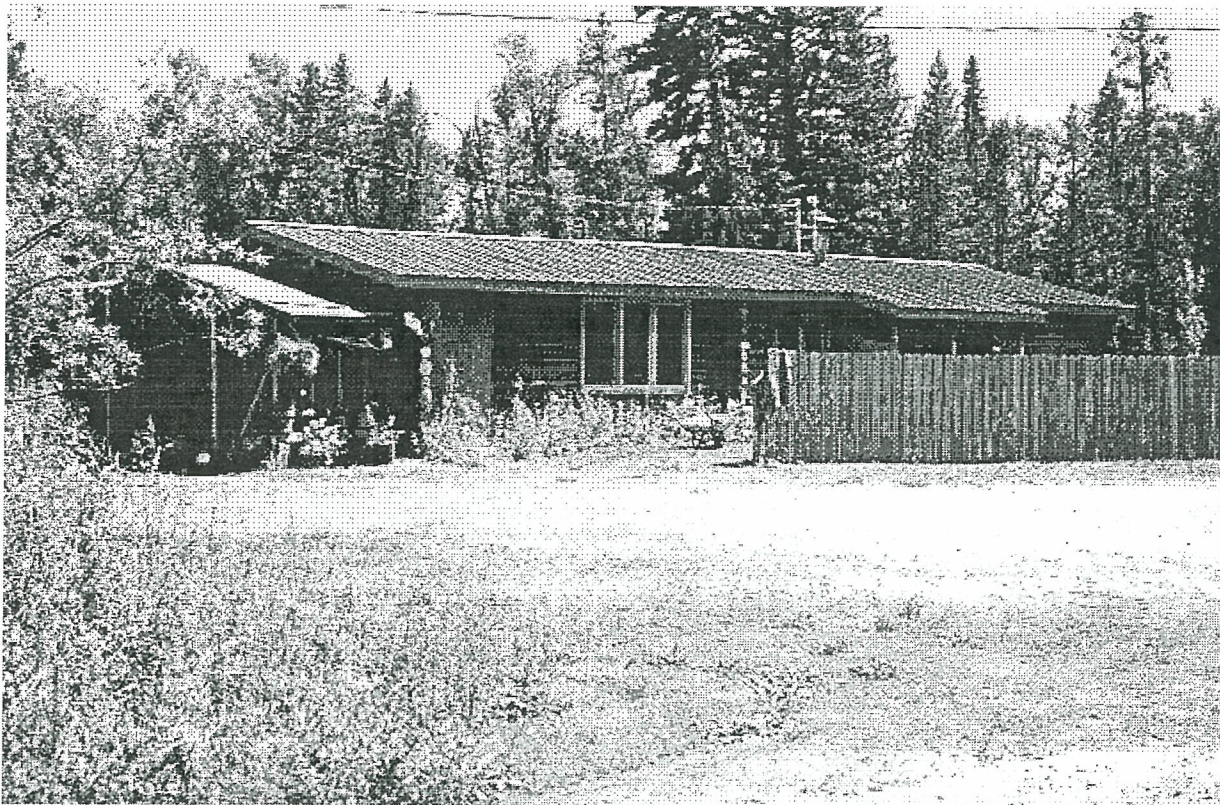
Feature 8. Bunkhouse. North and west elevations.

Feature 8. Bunkhouse.

This rectangular log structure, about forty feet long on its east and west elevations and about fifteen feet on its north – south elevations, was originally, likely in the 1940s, used as a coal bin; subsequently it became a bunkhouse for the wranglers on the ranch. The metal gable roof extends along the north – south axis. Columns of log crowns divide the west elevation into three segments, the northern-most portion being the longest and the southern-most being the shortest. Quarter-pole chinking and saddle-notched log corners are similar to those in other buildings on this ranch and in the valley. At the northern end a panel of vertical planks fills a gap between the logs and their crowns, as if the section of logs has been removed. In that same segment of the elevation, three vertical casement windows are arranged together to provide an opening; they appear to be of modern origin. The entrance is in the west elevation's middle section, between the two columns of crowns, and is protected by an extension of the eave beyond the elevation, which in turn is supported by vertical posts. The final segment, that portion of the elevation farthest south, has no openings. A utility shed, with a lower gable roof than that on the main building, has been attached to the north elevation, and a modern addition has been added behind the building, connecting to the east elevation with a gable roof that is perpendicular to and connecting to the gable roof of the main building.
