Associated Project Name Teton County Intensive Level Surveys 2016 (Teton County Historic Preservation Board)

Site Name Glenwood Street Leather Shop Temporary Field Number \_\_\_\_\_

Street address 145 N. Glenwood Street Town Jackson

**8F. HISTORIC ARCHITECTURE COMPONENT DESCRIPTION**

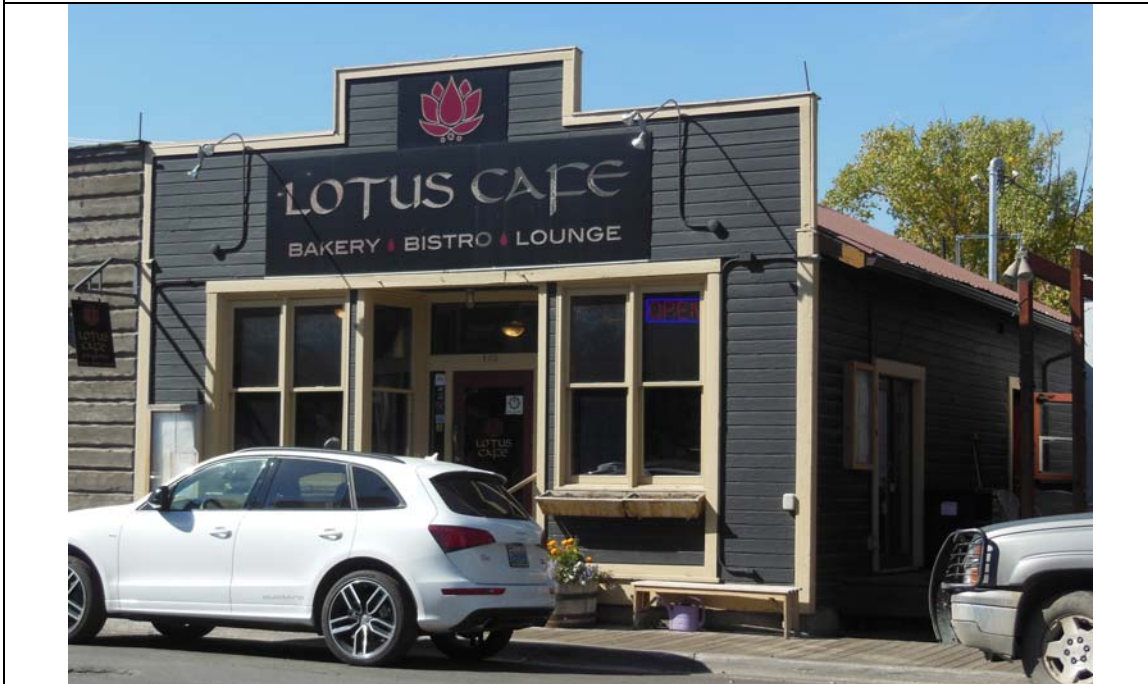
**Photograph 2**  
East and north elevations of shop, camera facing southwest.  
(photographed October 2016)

Roof (describe materials, i.e., asphalt, wood): The simple gable roof is covered in a circa 1990 rust-colored corrugated metal. Metal roof replacement is a common modification for Jackson's heavy snow fall. The false front completely obscures the metal roof from the façade view. The cornice appears to be original; however, only a small section is visible on the east elevation. There is a shed-roof covered in rolled asphalt shingles over the rear lean-to addition (circa 1980s). [Photographs 2-3]

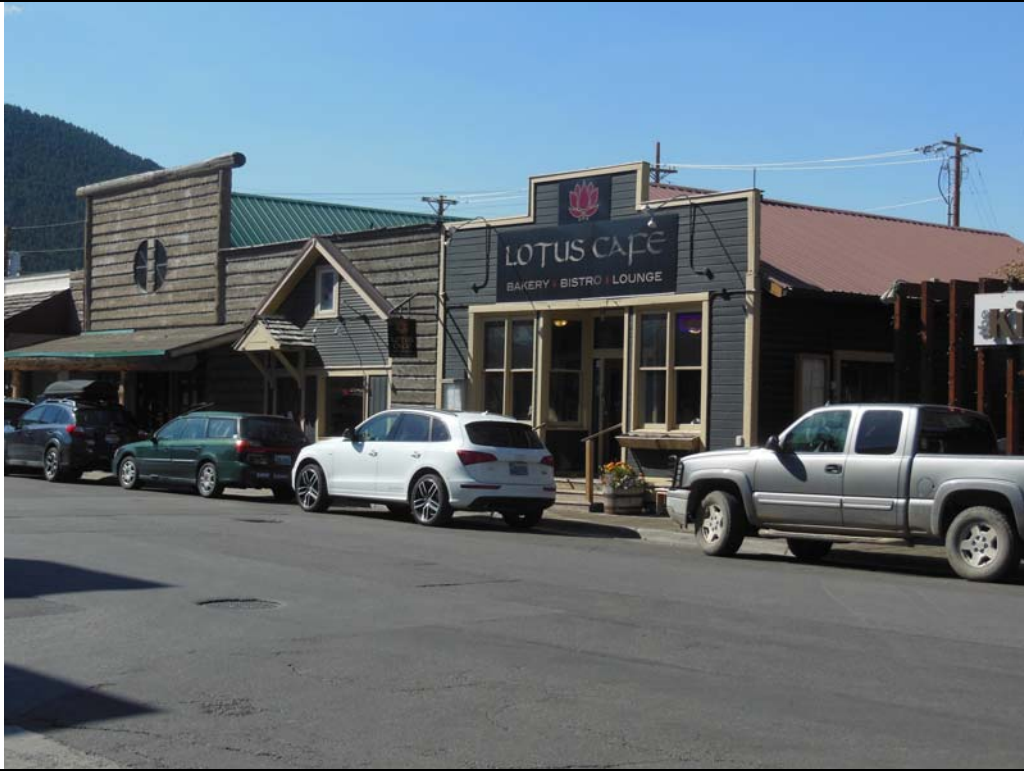
**Photograph 3**  
North and west elevations of complex, camera facing southwest.

Foundation (describe, i.e., stone, concrete, post and sill, etc.): The concrete foundation dates from the circa 1965 move. The original foundation material is unknown, but if the construction date of 1920 is correct, the original foundation was probably also concrete. [Photograph 3]

Modifications/Additions: The lean-to seen in a circa 1977 photograph features exposed rafters and multi-light wood windows that may have been original or an early addition. The lean-to was expanded and those features were removed (circa 1980s). The extensions of the false front façade to include a second historic building and a new building to the south utilizes heavy split log facing to create a nouveau rustic look. The extension has rendered the south historic building ineligible. [Photographs 3-5]

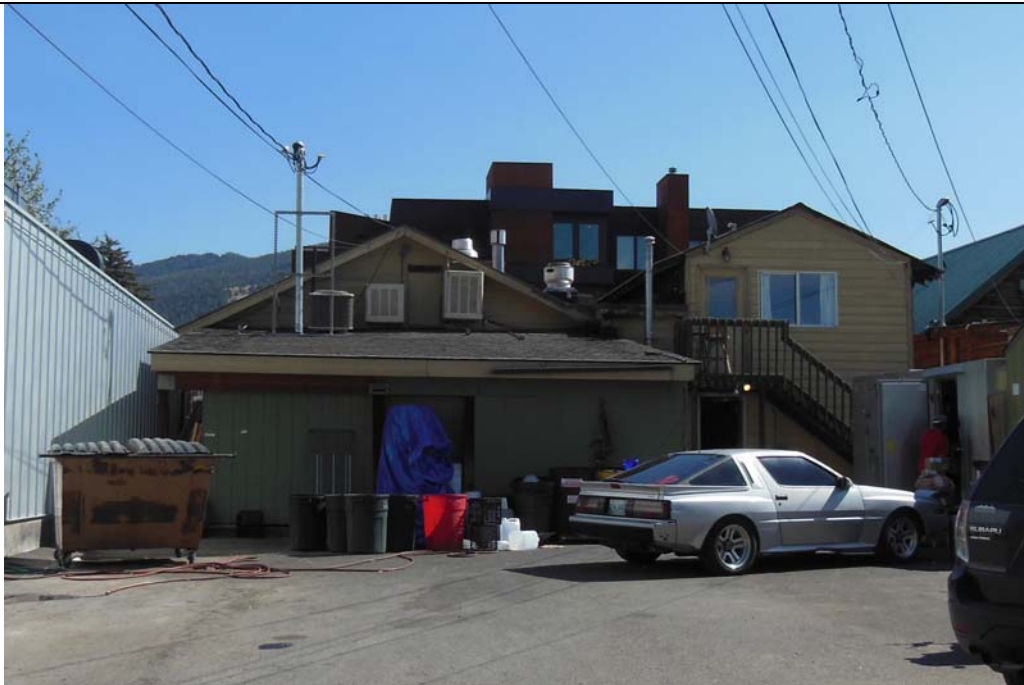
**Photograph 4**  
East elevation of complex, camera facing east.

Chimneys: There are no original chimneys, but there are later ventilation units above the kitchen area. [Photograph 4]

The second building to the south was likely built in the 1920s at its current site based on evidence in historic photographs. The building previously used the address 135 N. Glenwood Street. It is one-story at the front and two-stories at the rear. The front is clad in narrow clapboards under the gable. The storefront includes a single door and window surrounded by vertical plank siding (date unknown). The diamond-glass door, the vertical window, and the shingle covered shelter roof are not original. The removal of these features plus the surrounding rustic siding and false front compromise the integrity of this building. The rear of the building also has newer windows and doors and an exterior rear staircase to the upper floor. [Photographs 4-5]

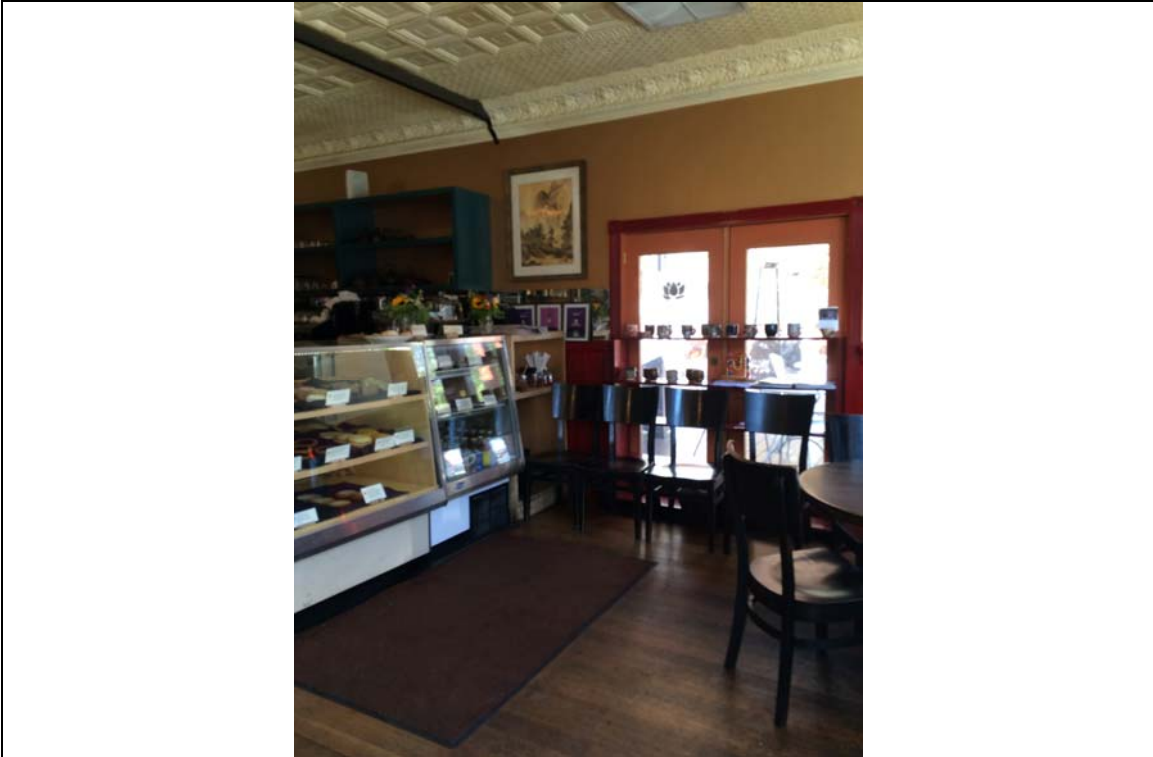
**Photograph 6**  
Interior of Lotus Café entrance, camera facing north.

Porches: As a commercial building, there is no front porch, but there is a recessed entry that is raised a couple of steps above the street level. The entry features wood steps, deck and rails. A pair of half-glass doors from the 1960s has been replaced by a historically compatible full-glass door with side lights. A raised deck extends along the north elevation. An original opening has been enlarged for sliding glass doors that open to the deck. Another door to the west is a later opening. A rear door on the lean-to was blocked when the lean-to was enlarged. [Photographs 1-4, 6]

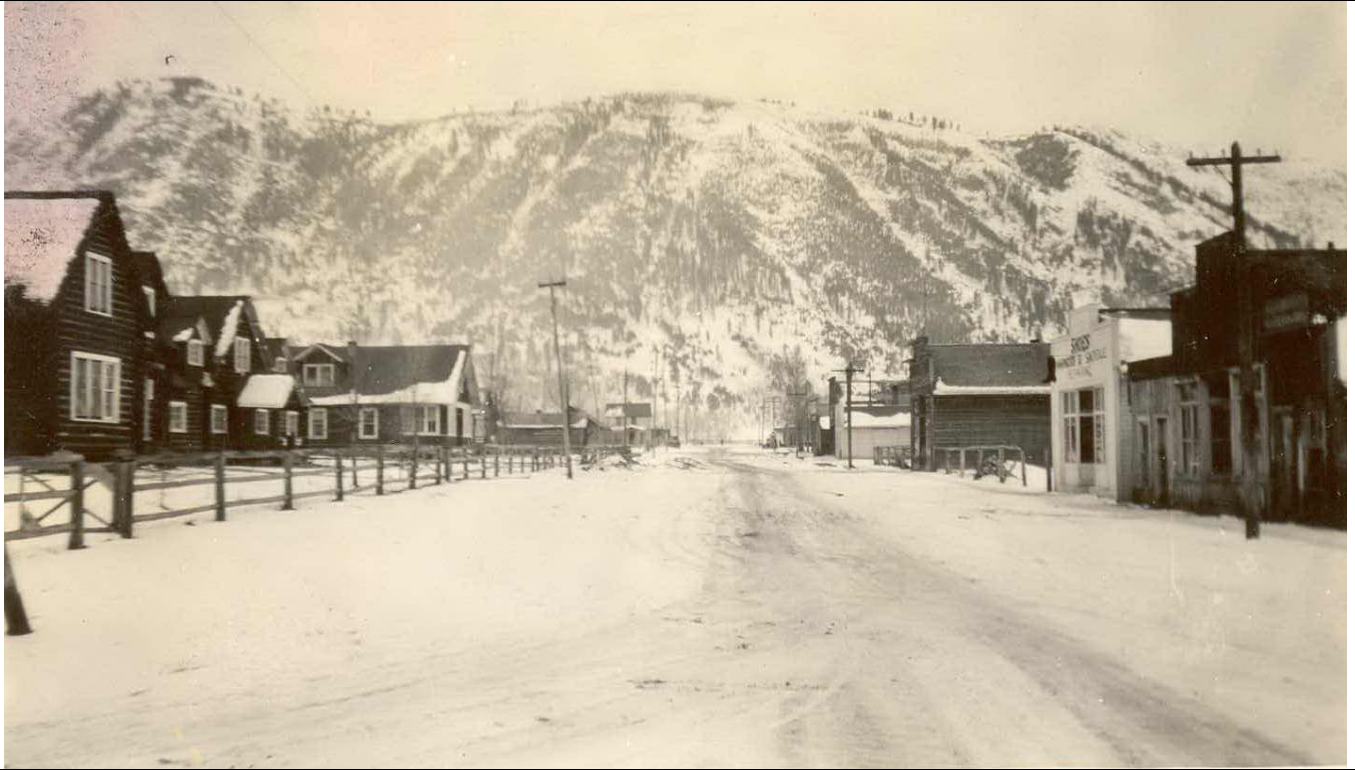
**Glenwood Street, circa 1930 (leather shop in white building on center right).**  
(courtesy Jackson Hole Historical Society)

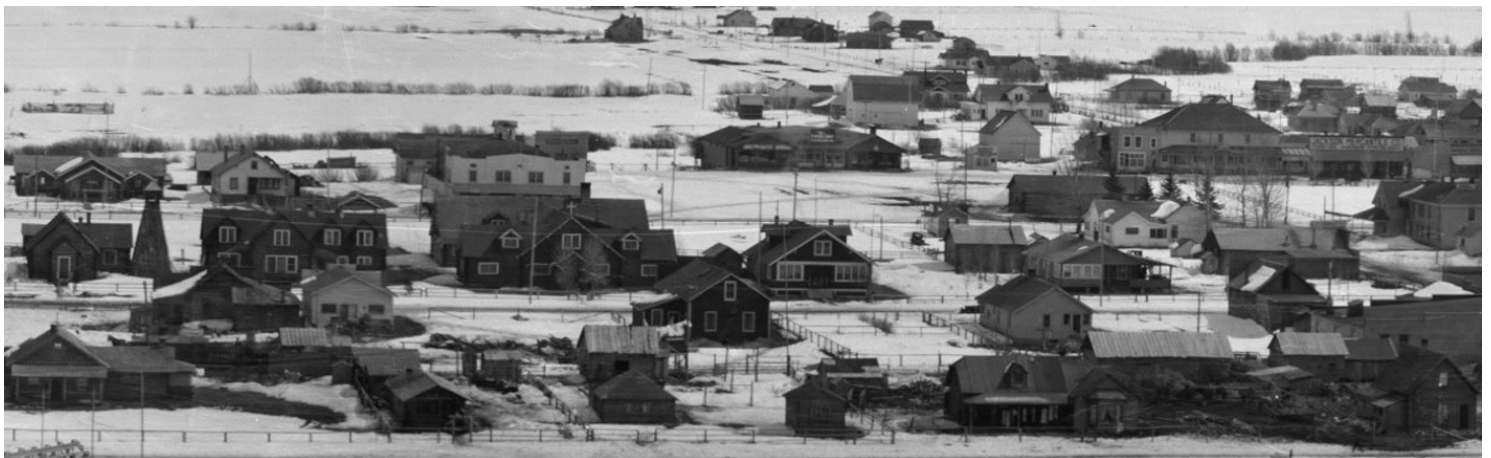
**Glenwood Street, rear of buildings, circa 1920  
(leather shop is second building from left in center).**  
(courtesy Stephen N. Leek photograph collection, American West Heritage Center, University of Wyoming)

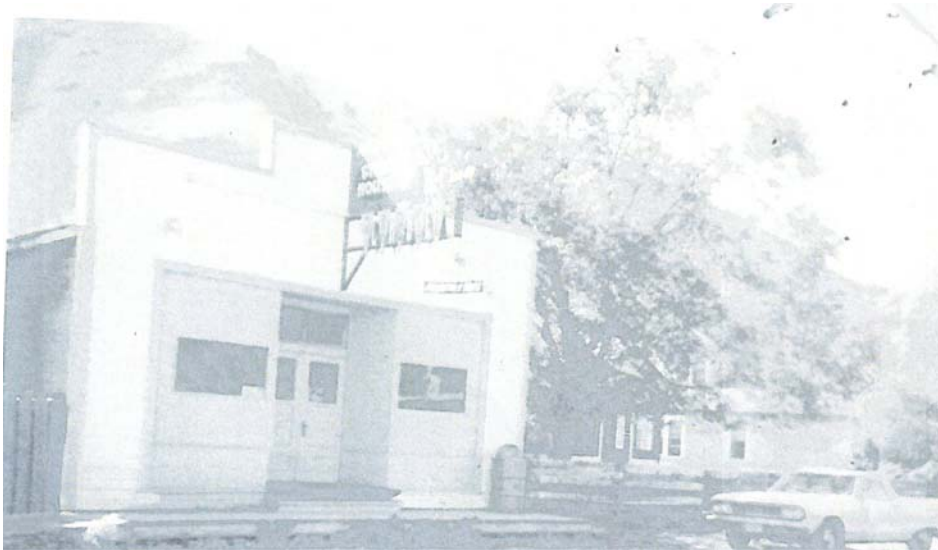
**145 N. Glenwood Street, west elevation, circa 1977**  
(courtesy Teton County Assessor's Office)

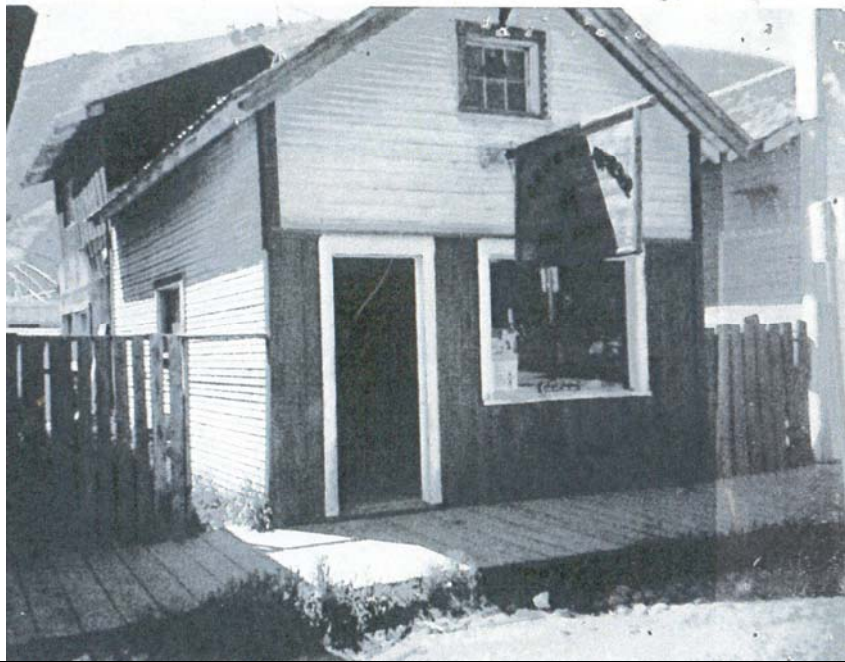
**135 N. Glenwood Street, east elevation, circa 1977**  
(courtesy Teton County Assessor's Office)
