Teton County Historic Site Survey

historic name Archie Teater Studio

Archie Teater Studio

Narrative Description

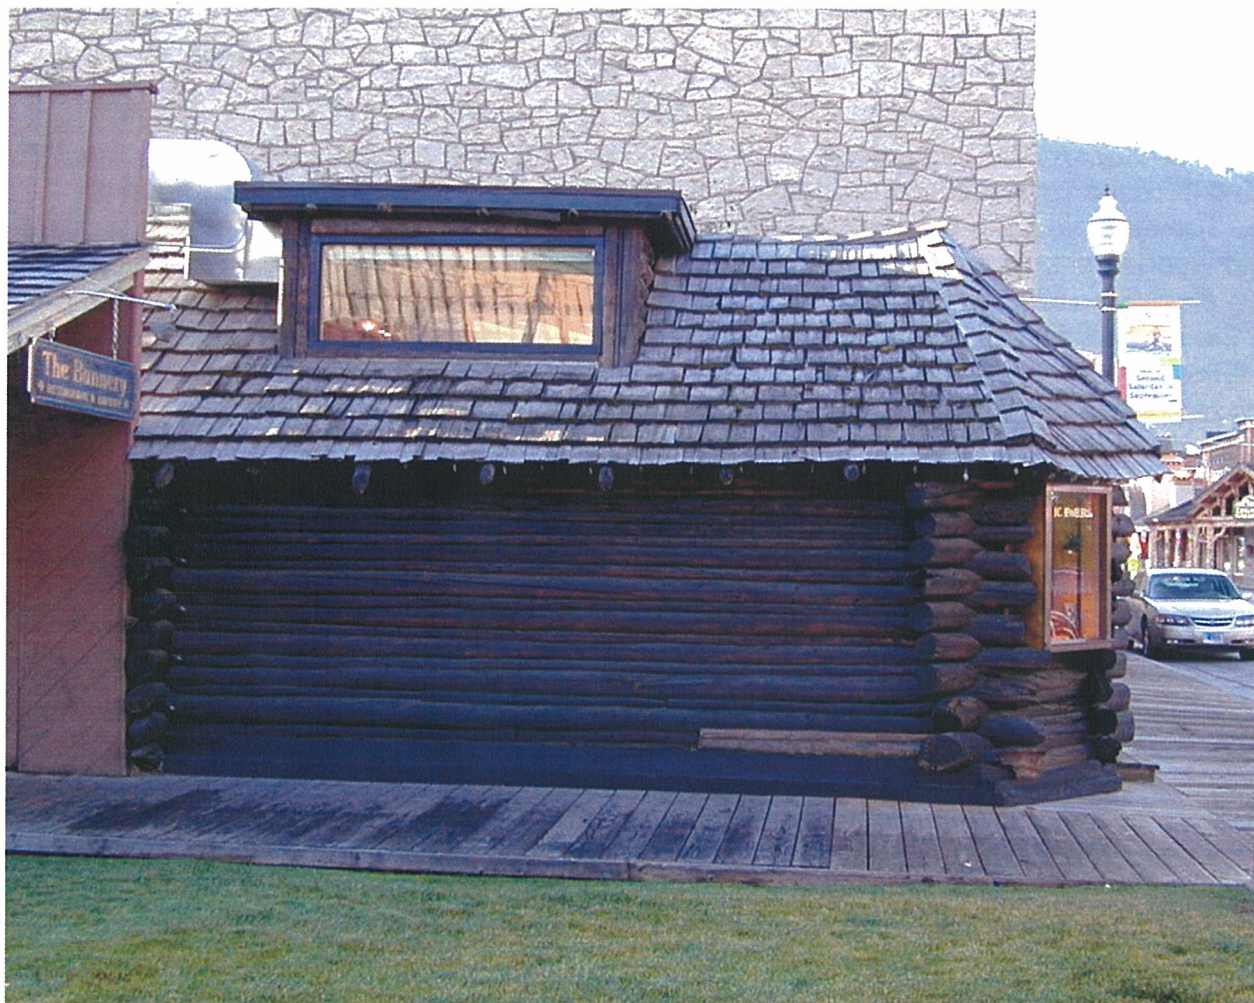
Archie Teater Studio, Jackson, Wyoming. Looking south. Photo: Michael Cassity, 2004.

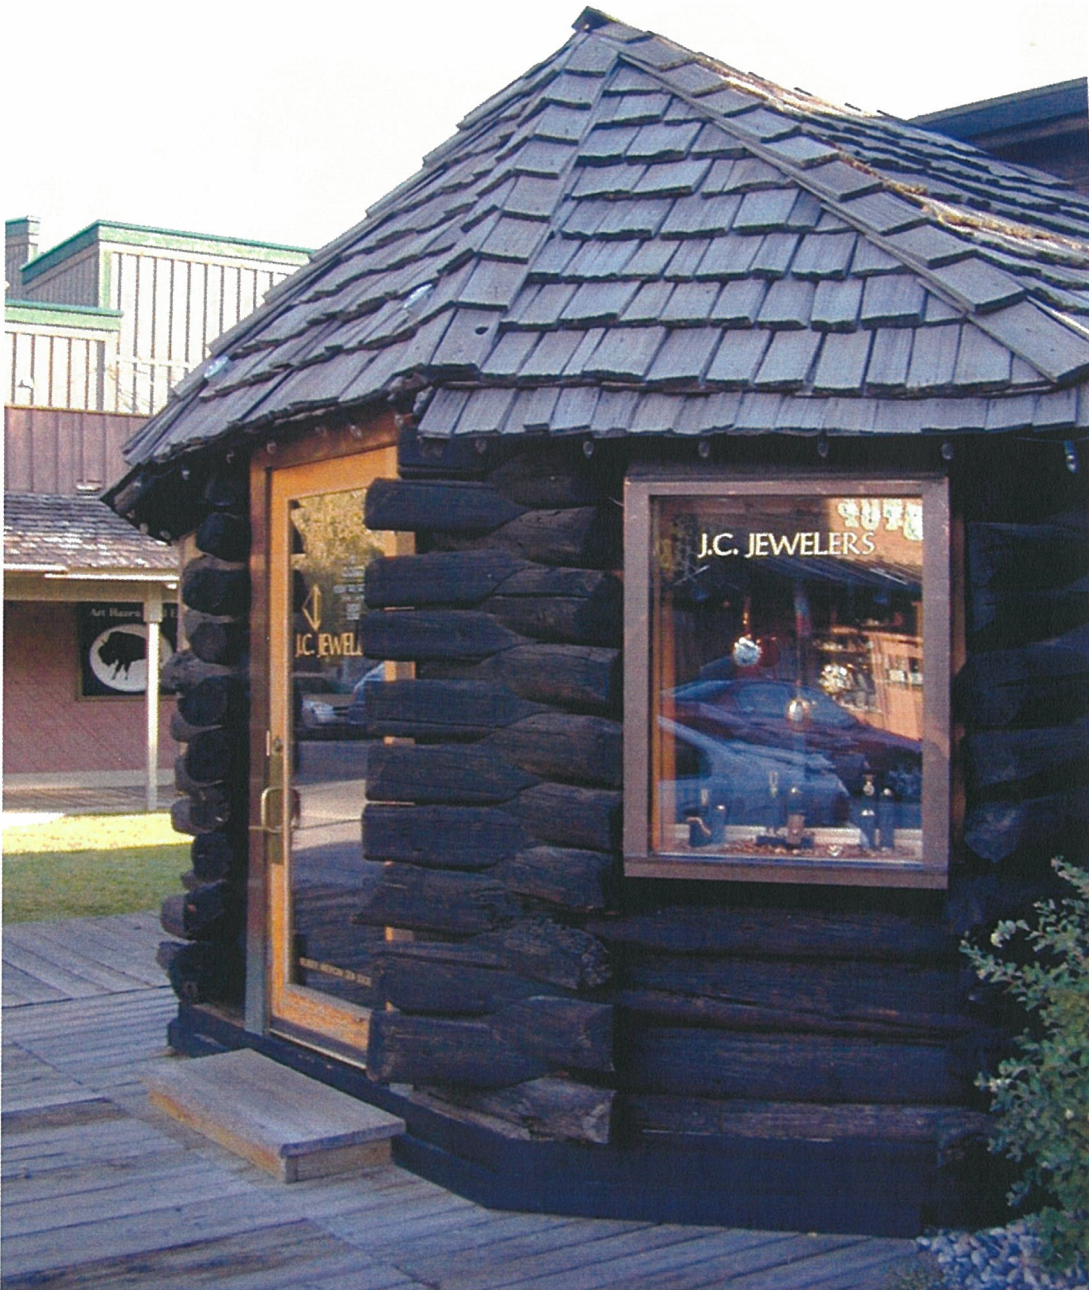
Archie Teater's Studio, now a building housing J. C. Jewelers, is a small, even tiny, L-shaped log and frame structure that faces west onto Cache in the block just north of the town square. Located immediately north of the Teton Theater, this building is in the heart of the town's business district and predates much of the construction in the area.

Despite the long windowless walls, the building is not dark. The traditional north-light window used by artists for natural, soft, indirect, and overhead light is provided for by a dormer window. In a twist to the tradition, however, a matching dormer window is located on the south slope of the roof too; because the building is protected part of the year from direct sunlight from the south by the tall theater next door, this south-light window allowed additional light without the harsh shadows of direct sunlight.

Archie Teater Studio, Jackson, Wyoming. Façade, looking northeast. Photo: Michael Cassity, 2004.

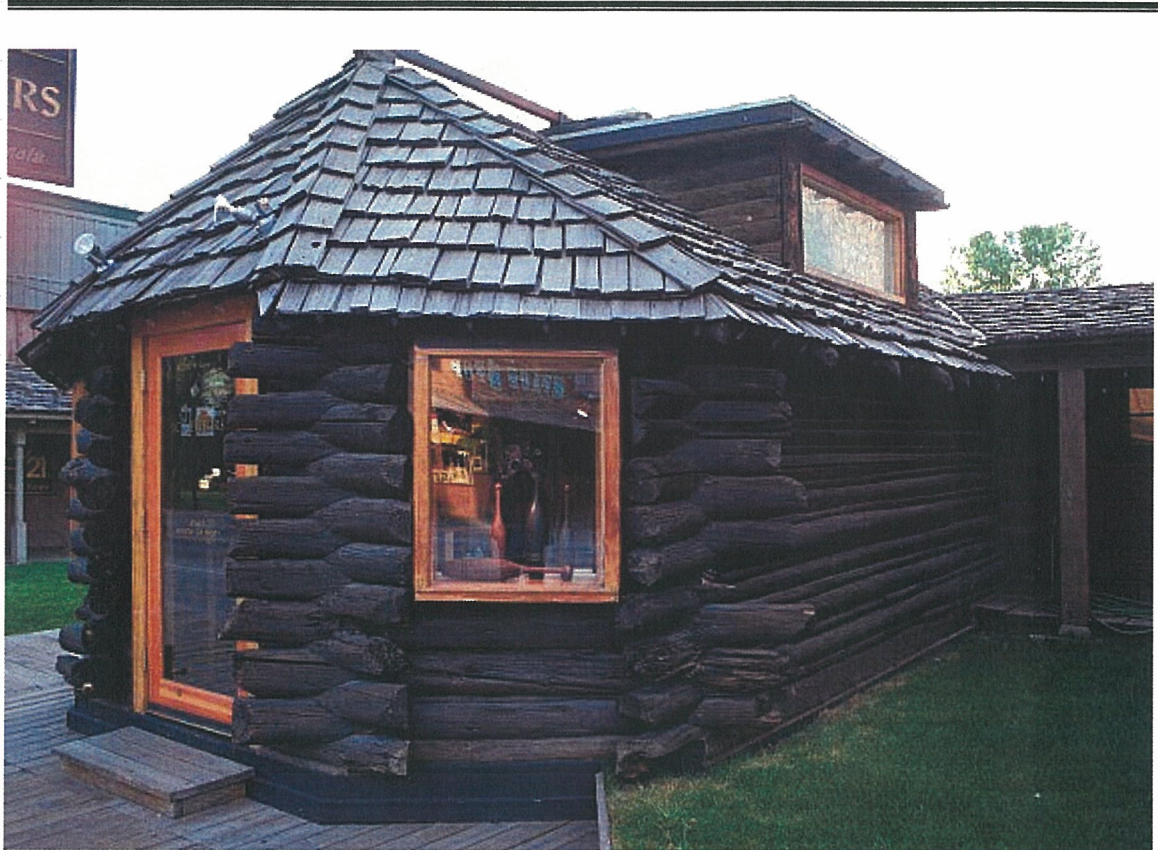
Archie Teater Studio, Jackson, Wyoming. Looking northeast (prior to shrubbery planting and growth). Photo: Michael Cassity, 1999.

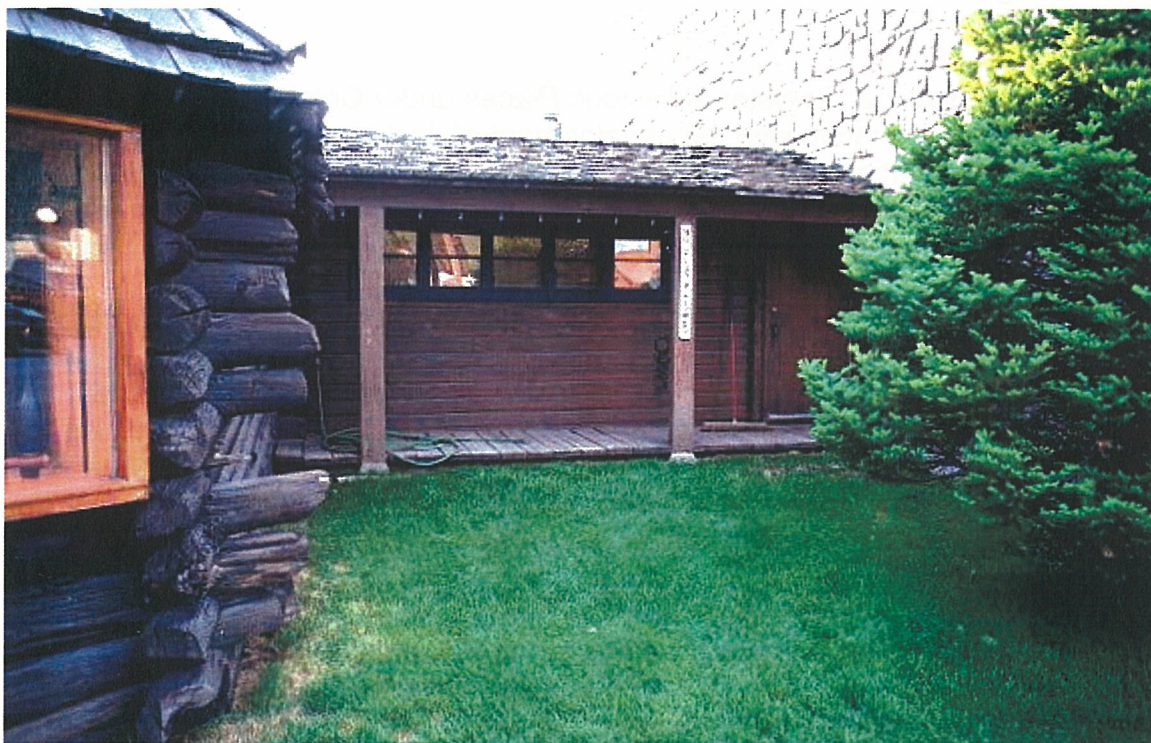
The south wing of the building appears to have been added at a later date. It projects from the east extreme of the south elevation and is obscured by trees, shrubbery, and artwork. The dark coloration of the wood plank siding (which matches the stain on the logs on the original building) further obscures the addition and keeps it from compromising the integrity of the building. With a lower roofline than the original, with eaves that extend well beyond the elevation (and are supported by square columns) to protect a wooden walk below, and with a series of three horizontal windows, this addition also contains a windowless door.

Archie Teater Studio, Jackson, Wyoming. South wing, looking east. Photo: Michael Cassity, 1999.
