Associated Project Name First Baptist Church of Jackson Hole Parsonage

Site Name First Baptist Church of Jackson Hole Parsonage Temporary Field Number _____

Street address 630 East Broadway Town Jackson

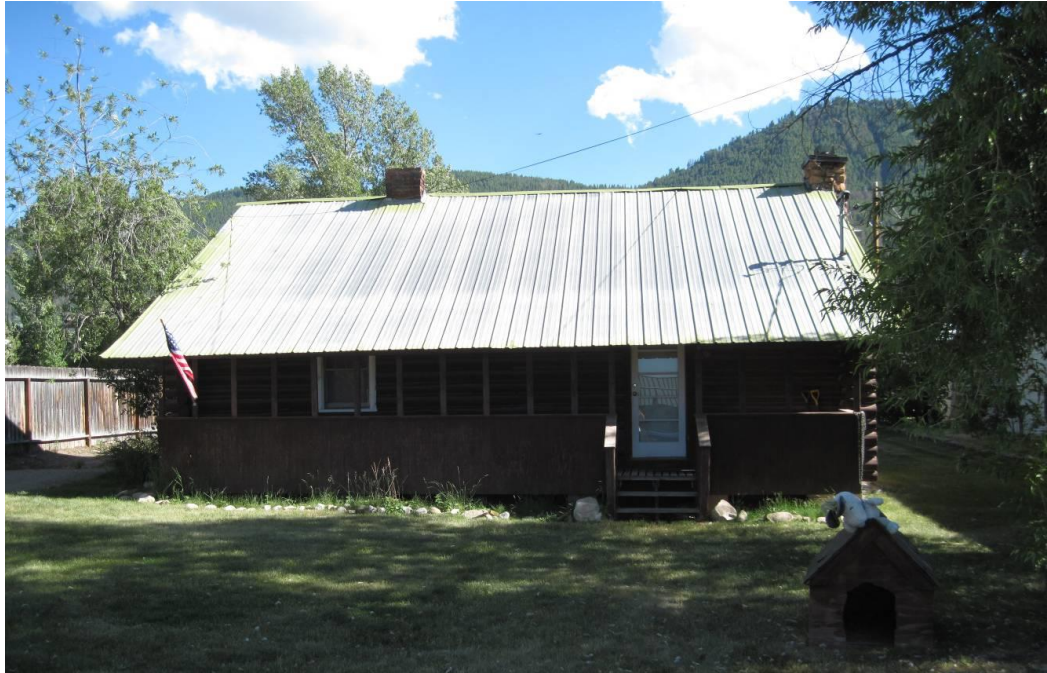
First Baptist Church of Jackson Hole Parsonage, North Elevation, Longfield, 2009

The parsonage is a one-and-a-half story, 41-foot wide by 36-foot deep structure made of log construction. Log walls are joined with saddle notching and the building currently has a green metal roof. Where the exterior is log, the walls are chinked with quarter-round wood chinking. A continuous poured concrete foundation runs around the entire structure. The structure has two chimneys. The western-most chimney is square and composed of orange and red field stone and the second, more central chimney, is also square, and constructed of brick. The north elevation has two, double-hung windows and a central, single-panel door. A simple plywood and dimensional lumber deck runs the length of the north elevation.

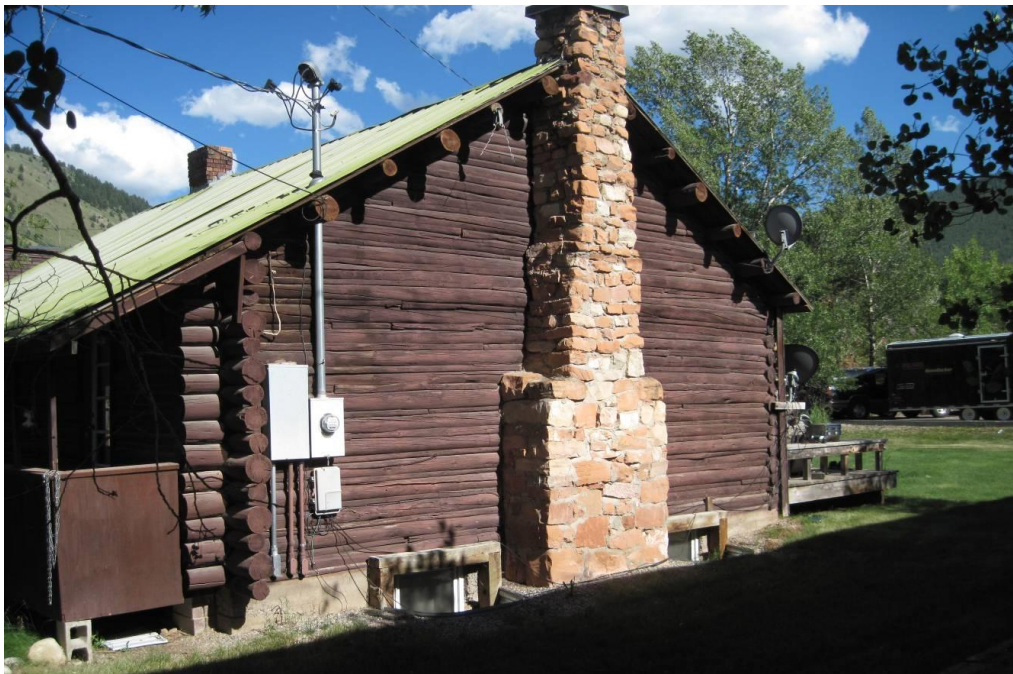
First Baptist Church of Jackson Hole Parsonage, West Elevation, Longfield, 2009

The west elevation features a central field stone chimney and has no windows or doors.

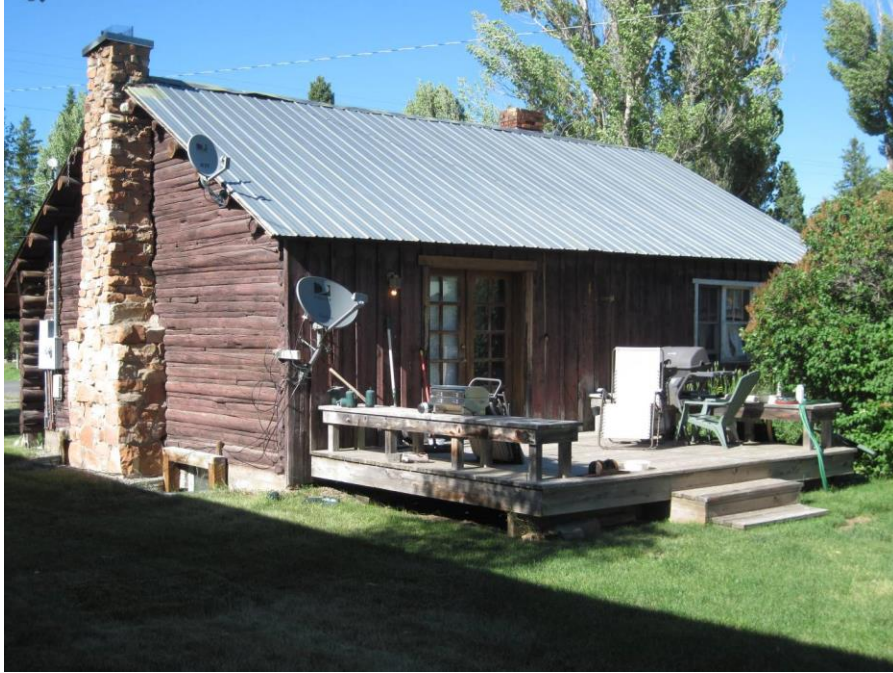
First Baptist Church of Jackson Hole Parsonage, South Elevation, Longfield, 2009

The south elevation has a board deck that runs the western two-thirds of the elevation. A double, French door is centered on that deck and a paired double-hung window is located to the east of the deck. The entire south elevation is faced with board and batten suggesting that southern exposure on this elevation may have prompted the owner to face over the deteriorating logs.

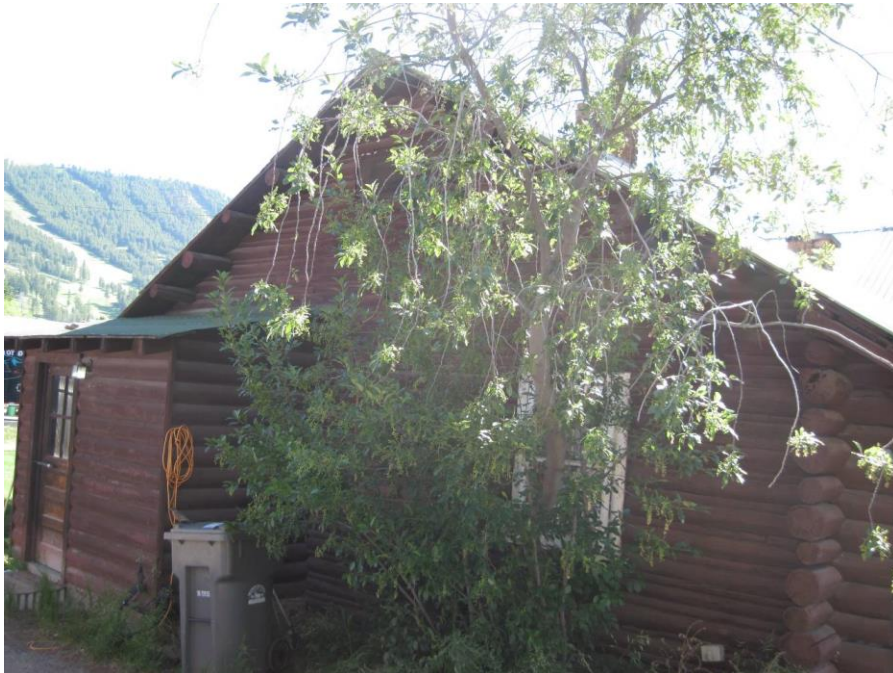
First Baptist Church of Jackson Hole Parsonage, East Elevation, Longfield, 2009

The southern end of the eastern elevation includes a simple, half-log shed vestibule addition. The northern portion of the east elevation has two windows. The more central window is a small casement window and the one toward the north is a double-hung window.

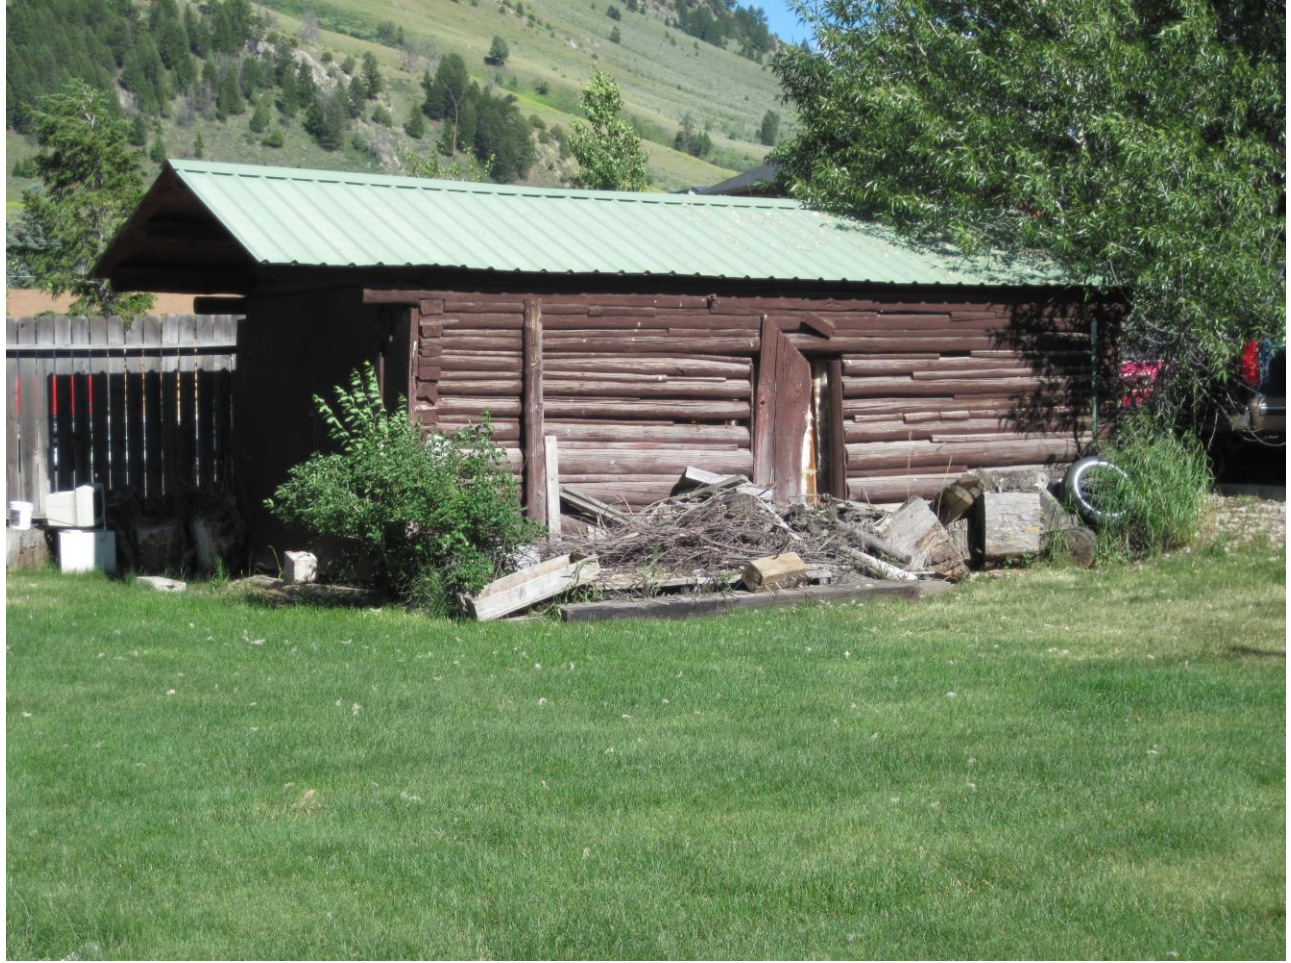
First Baptist Church of Jackson Hole Parsonage, Garage, West and North Elevations, Longfield, 2009

A secondary building sits to the east of the main residence, immediately adjacent to the fence. The building is approximately 10 feet wide by fifteen feet long. The north, primary elevation features two adjoining oversized doors that occupy almost the entire facade and the west elevation contains the jam for a missing door. The walls are log and are joined by square notches. The front (north facing) gable extends well beyond the garage-door wall. The building is capped with a green metal roof.
